Moly Does the Job

Summary

A large, international, food manufacturing company encountered through-wall leaks in a Type 304 stainless steel hot water line after only two years of service. The leaks were caused by a combination of Microbiologically Influenced Corrosion (MIC) and manganese pitting corrosion. An upgrade to the more corrosion resistant 6% molybdenum stainless steel permanently solved the problem. Three years after the initial piping replacement, the plant completed replacement of the entire hot water line with 6% molybdenum high performance stainless steels.

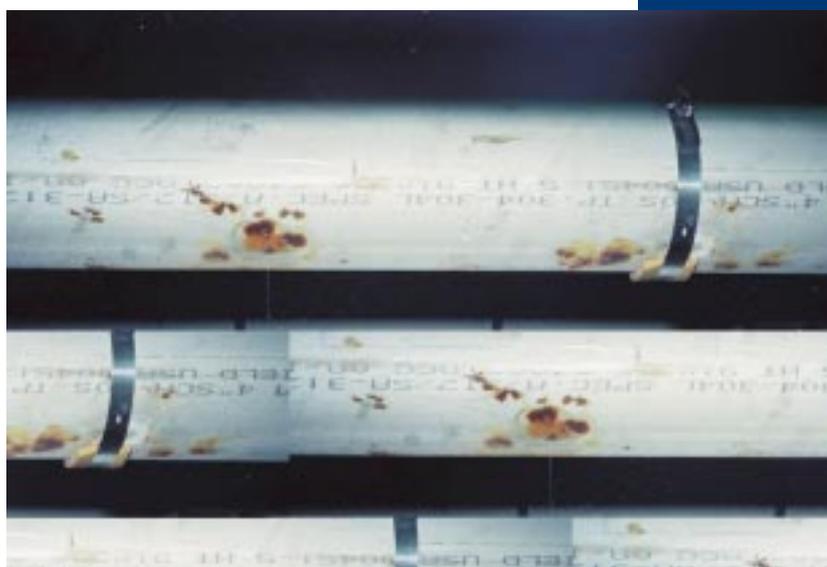
The chloride content of the hot water is 50 to 100 ppm. The chlorination target is 0.2 to 0.3 ppm and never exceeds 0.5 ppm free chlorine. These are moderate concentrations which normally are considered to be below the critical level which might cause pitting in Type 304. However, pitting occurred in numerous places, predominantly in the mid-length section of the line in the lower third of the piping cross section.

The pitting was thought to be related to the high manganese content of the water. If manganese-metabolizing bacteria are

Fig 1: Numerous pits are found on the lower third of the pipe. A patch, covering a leak, is seen in the picture.

present, manganese can be transformed into the permanganate ion. In association with the chloride ion, permanganate can initiate pitting in Type 304 stainless steel. This form of corrosion is relatively rare, but if it occurs, propagation may be rapid. Further evidence for this mechanism, in addition to the presence of metal-oxidizing microbes in the water, was the location of the pitting in portions of the line where intermediate temperatures prevailed. It did not occur initially with the high temperatures in the heat exchanger or the relatively cool ones at the end of the water line. Bacterial activity is greatest at somewhat elevated temperatures.

It could not be determined whether the pitting was caused by MIC (due to the manganese-metabolizing bacteria) or by manganese pitting (due to the interaction with chlorine). However, both mechanisms can be prevented through a change in water chemistry, which is usually not practical, or through a significant upgrade in the corrosion performance of the piping material. In this case, the company decided to replace the Type 304 with the 6% molybdenum stainless steels, UNS S31254 and UNS N08367. Upgrading only to Type 316 stainless steel (2% Mo) is normally not sufficient to prevent MIC or manganese pitting.

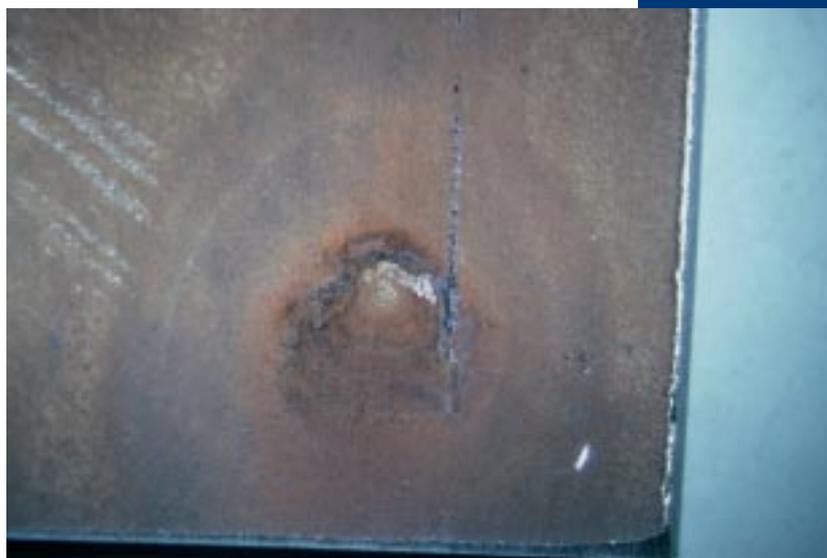
Fig 2: Close-up of the pitting corrosion.
