Moly Does the Job

Stainless Steel with 6% Mo Improves Equipment Efficiency and Eliminates Costly Repair.

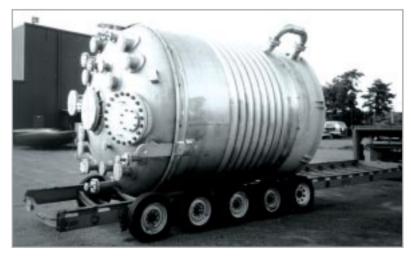
General and oxygen cell pitting corrosion occurred on both the carbon steel half pipe cooling jacket and the carbon steel exterior vessel wall. The attack occurred over the entire surface but was slightly more aggressive in weld areas where slag inclusions or lack of penetration was apparent.

Historically, the corrosion caused leaks in the carbon steel half pipe jacket and thinning of the carbon steel side of the stainless clad vessel wall. Frequent repair welding was required to stop the leaks and to build back the lost wall thickness. Eventually the problem became significant enough to downgrade the pressure rating for the vessel. A complete replacement of the vessel was required. The Type 316L stainless cladding was fully resistant to the process side environment.

Figure 1: Process vessel constructed in 6% molybdenum stainless steel.

Corrosion coupons of 6% molybdenum stainless steel were installed in the existing equipment for a one-year period to determine if it was a suitable replacement material. The 6% molybdenum grades showed corrosion rates of less than 2 mpy (0.05 mmpy) and no initiation of CSCC.. One of them was therefore selected as material for the replacement vessels

Use of the higher strength 6% molybdenum stainless steel provided a significant reduction in the required vessel wall thickness. This resulted in cost savings of almost 30% in material and fabrication cost compared to a clad vessel. Additionally, operating advantages were gained since the reduced wall thickness results in better heat transfer. The improved corrosion resistance on the process side, while not initially required, provides flexibility for future process changes. Finally, the jacket side corrosion resistance provides a significant savings in long-term maintenance cost. It is estimated that the repair cost of the carbon steel exceeded \$500,000 every five years.

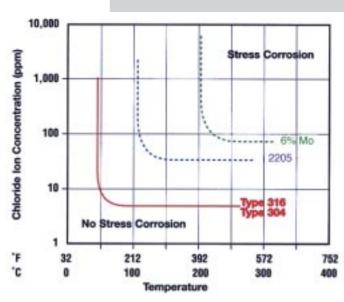
steam side and the chemical on the process side. Type 316L stainless steel does provide sufficient resistance to the process environment, but, based on extensive field experience, cannot be expected to resist CSCC on the steam side. Figure 2, which summarizes field experience in Types 304 / 304L (UNS S30400/30403. EN 1.4301/1.4307) and 316/316L (UNS S31600/S31603, EN 1.4401/1.4404) and extrapolates from laboratory tests for higher alloyed grades, shows that Type 316L will suffer from CSCC at the heating temperature of 275°F (135°C) at chloride levels below approximately 10ppm. Even duplex stainless steel such as 2205 (UNS S32205 or S31803,EN 1.4462) which generally provides much better resistance to CSCC than Type 316 is expected to stress crack under the operating conditions. Based on this figure, the group of super austenitic 6% molybdenum stainless steels (e.g. UN S31254, NO8926 or NO8367; EN 1.4547, 1.4529), should provide sufficient resistance to CSCC under the operating conditions. They should also be at least as resistant to the process environment as the lower-alloyed Type 316L stainless steel and were therefore selected as a candidate material.

Figure 2: Limits for chloride stress corrosion cracking in cooling waters as a function of chloride content and water/steam temperature. The 6% Mo stainless steel curve is also valid for super duplex stainless steels such as 2507. (UNS S32750, EN 1.4410) (Adapted from Nickel Development Institute Reference Book Series No 11 021, High Performance Stainless Steels, Figure 63).
