Moly Does the Job

Stainless Steel with 6% Mo Improves Equipment Efficiency and Eliminates Costly Repair.

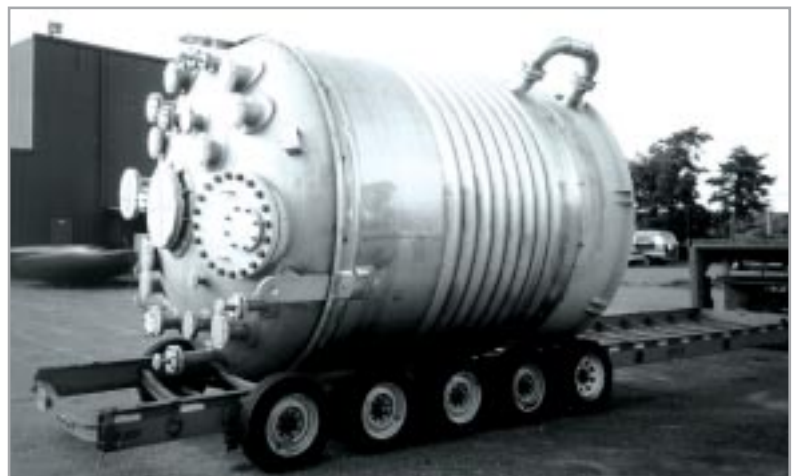
General and oxygen cell pitting corrosion occurred on both the carbon steel half pipe cooling jacket and the carbon steel exterior vessel wall. The attack occurred over the entire surface but was slightly more aggressive in weld areas where slag inclusions or lack of penetration was apparent.

Historically, the corrosion caused leaks in the carbon steel half pipe jacket and thinning of the carbon steel side of the stainless clad vessel wall. Frequent repair welding was required to stop the leaks and to build back the lost wall thickness. Eventually the problem became significant enough to downgrade the pressure rating for the vessel. A complete replacement of the vessel was required. The Type 316L stainless cladding was fully resistant to the process side environment.

Figure 1: Process vessel constructed in 6% molybdenum stainless steel.

Corrosion coupons of 6% molybdenum stainless steel were installed in the existing equipment for a one-year period to determine if it was a suitable replacement material. The 6% molybdenum grades showed corrosion rates of less than 2 mpy (0.05 mmpy) and no initiation of CSCC.. One of them was therefore selected as material for the replacement vessels.

Use of the higher strength 6% molybdenum stainless steel provided a significant reduction in the required vessel wall thickness. This resulted in cost savings of almost 30% in material and fabrication cost compared to a clad vessel. Additionally, operating advantages were gained since the reduced wall thickness results in better heat transfer. The improved corrosion resistance on the process side, while not initially required, provides flexibility for future process changes. Finally, the jacket side corrosion resistance provides a significant savings in long-term maintenance cost. It is estimated that the repair cost of the carbon steel exceeded \$500,000 every five years.

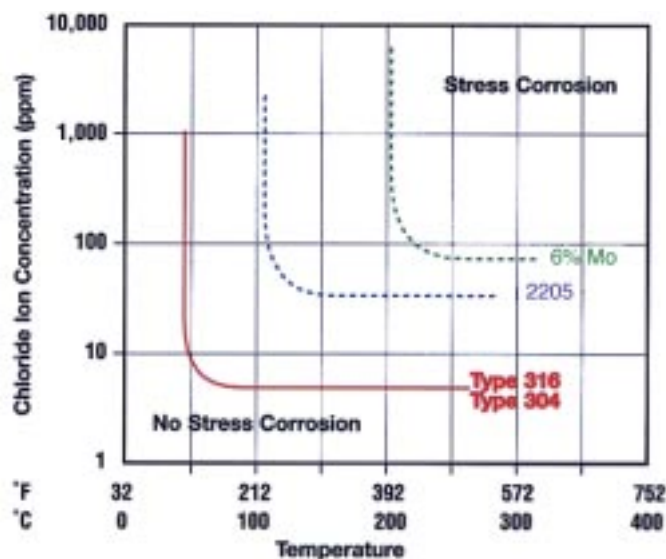
steam side and the chemical on the process side. Type 316L stainless steel does provide sufficient resistance to the process environment, but, based on extensive field experience, cannot be expected to resist CSCC on the steam side. *Figure 2*, which summarizes field experience in Types 304 / 304L (UNS S30400/30403, EN 1.4301/1.4307) and 316/316L (UNS S31600/S31603, EN 1.4401/1.4404) and extrapolates from laboratory tests for higher alloyed grades, shows that Type 316L will suffer from CSCC at the heating temperature of 275°F (135°C) at chloride levels below approximately 10ppm. Even duplex stainless steel such as 2205 (UNS S32205 or S31803, EN 1.4462) which generally provides much better resistance to CSCC than Type 316 is expected to stress crack under the operating conditions. Based on this figure, the group of super austenitic 6% molybdenum stainless steels (e.g. UN S31254, N08926 or N08367; EN 1.4547, 1.4529), should provide sufficient resistance to CSCC under the operating conditions. They should also be at least as resistant to the process environment as the lower-alloyed Type 316L stainless steel and were therefore selected as a candidate material.

Figure 2: Limits for chloride stress corrosion cracking in cooling waters as a function of chloride content and water/steam temperature. The 6% Mo stainless steel curve is also valid for super duplex stainless steels such as 2507. (UNS S32750, EN 1.4410) (Adapted from Nickel Development Institute Reference Book Series No 11 021, High Performance Stainless Steels, Figure 63).
