## Moly does the Job

### Summary

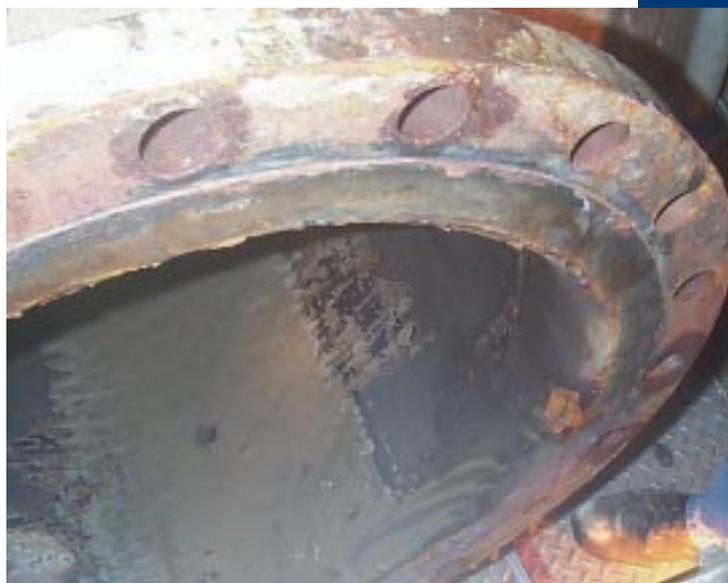
Extensive weld metal and heat affected zone corrosion was observed on the carbon steel piping where the cement lining had cracked at the welds. Polyethylene linings failed due to erosion, which lead to subsequent erosion and corrosion of the underlying carbon steel base material. The Type 316 stainless steel failed due to through-wall pitting corrosion in areas of stagnant water within three years of operation. Galvanic corrosion was observed in joints where carbon steel and stainless steel were welded together. Mating surfaces of Type 316 stainless steel and of rubber lined carbon steel valves showed pitting and crevice corrosion. Finally, extensive exterior corrosion was observed on carbon steel piping under insulation where condensation water was kept in contact with the (unlined) carbon steel.

The brackish, silt-containing water caused the corrosion and erosion on the lined carbon steel in places where the lining was flawed or eroded. Carbon steel has no inherent corrosion resistance under these conditions if the lining fails for any reason.

*Figure 1: Lined carbon steel spool piece from intake structure. Significant corrosion can be observed on the edges of the pipe, where the lining has imperfections.*

About ten years into the operation of the power plant, it became apparent that the replacement of some of the lined carbon steel with Types 304 and 316 stainless steel was not a permanent solution. In 1986 the power plant started to install small amounts of highly corrosion resistant 6% molybdenum containing stainless steel. More of the high performance stainless steel was installed at every refuelling outage and thus all of the above ground service water system was gradually replaced. Today only a few spool pieces of lined carbon steel remain in the system. *Figure 1* shows one of these remaining pieces that is exhibiting extensive corrosion. These pieces are very difficult to replace because they penetrate concrete walls and are anchored to these walls. Nevertheless, the engineering staff is in the process of finding ways to replace these last pieces of carbon steel in the system.

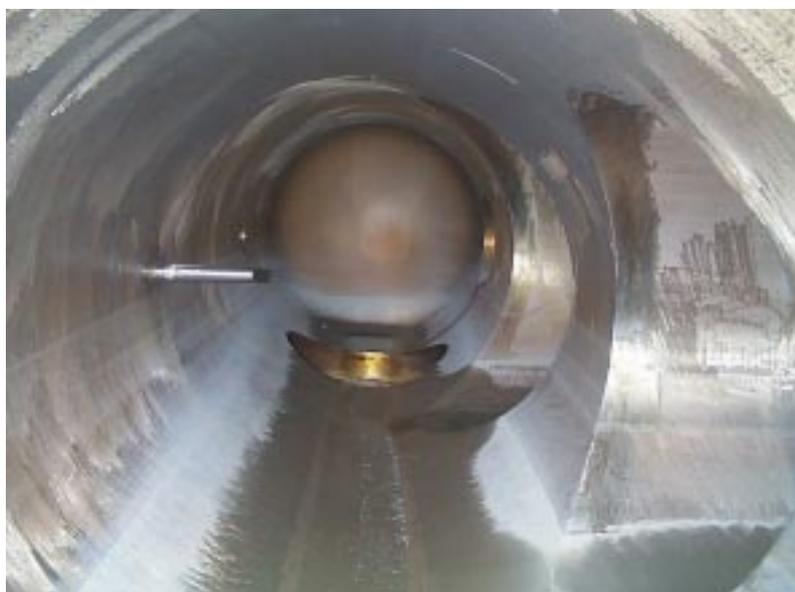
The plant has been extremely pleased with the performance of the 6% molybdenum stainless steel. The piping hardly requires any maintenance and no longer needs to be inspected during each outage. All of it remains in perfect condition. *Figure 2* shows the interior of the pump discharge distribution header made of 6% molybdenum stainless steel. The stainless steel has been in continuous service for 30 months and had not been cleaned before this picture was taken. The total time in service for this part of the piping has been six years.

*Figure 2: Interior of the pump discharge distribution header made of 6% molybdenum stainless steel before cleaning. After 30 months of operation no corrosion or other build up has formed on the pipe walls.*
