Case Study 01 Pittsburgh and Chicago Handrails and Street Furniture

Moderate Urban Pollution

High to Low Deicing Salt Exposure

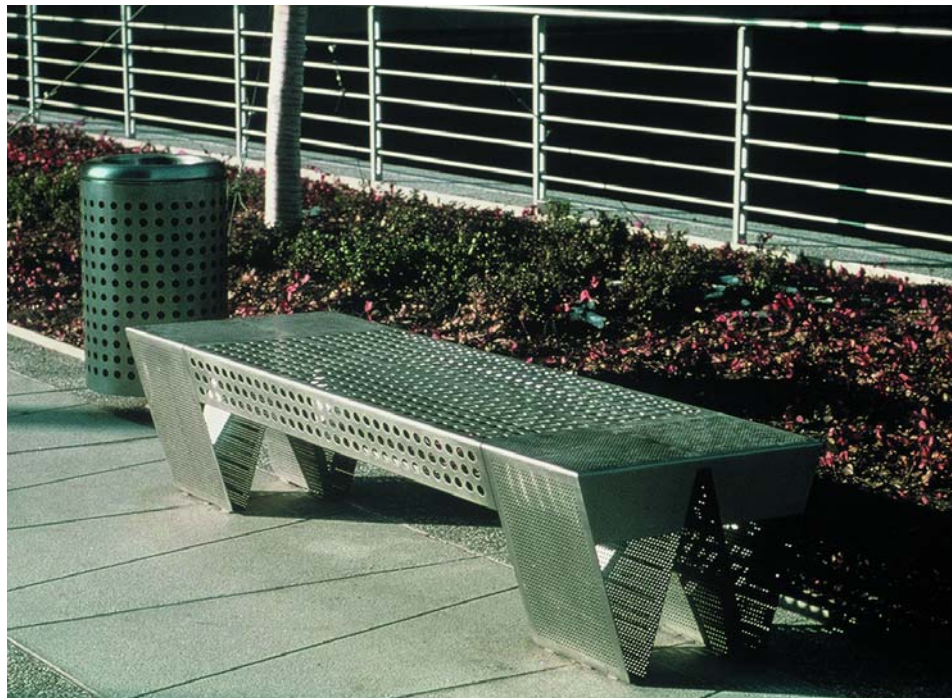
In downtown Chicago, Illinois, USA, this Type 316 (UNS S31600, EN 1.4401, SUS 316) stainless steel bench and handrail are in pristine condition after five years of service (**Figure A**). The handrail is adjacent to a sidewalk and about 1 meter (a few feet) from a busy road where deicing salt is used. The bench is in an adjoining park.

Type 316 contains 2% molybdenum, which improves pitting and crevice corrosion resistance. This is particularly helpful in preventing salt damage. The use of Type 316, a smooth surface finish, and natural rain and maintenance cleaning keep this street furniture attractive despite the severe environment.

Figure A Specification of Type 316 stainless steel, a smooth finish and a design that takes advantage of rain washing keep this bench and handrail beautiful. (Photo Courtesy of Paul Pittsford)

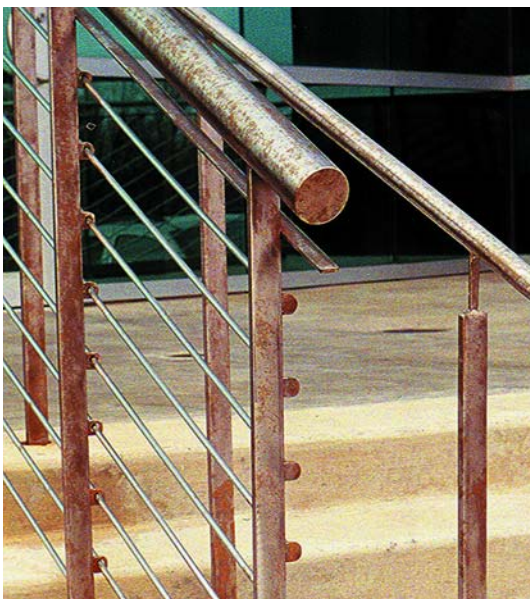
Figure B Type 304 stainless steel with a rough finish was the wrong choice for handrails exposed to deicing salt laden road mist. Cleaning will remove the staining but it will reappear every year. (Photo Courtesy of TMR Stainless)

In contrast, Type 304 (UNS S30400, EN 1.4301, SUS 304) stainless steel handrails were corroded and badly stained after only one winter in Pittsburgh, Pennsylvania, USA (**Figure B**). The railings were installed the preceding autumn. Type 304 does not contain molybdenum and is therefore more susceptible to chloride corrosion than Type 316.

The railings are located approximately 90 meters (300 feet) uphill from a busy highway. No deicing salt was used on the steps beside the railing. Wind has carried road mist, laden with deicing salts, up the hill and, deposited it on the railings.

The tubing was purchased with a mill finish. During fabrication, a coarse abrasive pad was applied to the surface producing a rough, directional, brushed appearance. The same procedure was used for the bar. Only the small diameter rods have a smooth finish which is why they have significantly less corrosion.

Salt and corrosive pollutants more readily adhere to rough surfaces and even regular heavy rain may not completely remove deposits. The use of rough surface finishes increases the probability of corrosion damage.

Type 304 will stain and corrode when exposed to deicing salt. Refinishing the railing to obtain a smooth finish which minimizes deicing salt accumulation ($\leq R_a$ 0.5 μm or 20 μin) could reduce the Pittsburgh score to a 2, indicating that 304 can be considered. Alternatively, the railing could be cleaned regularly. Even with a smoother finish, there may be some corrosion staining of Type 304 over time and occasional cleaning may be required. If airborne dust in the warmer months contains measurable salt levels, more frequent cleaning may be necessary.
