Case Study 02 Minneapolis Exterior Wall Panels and Window Frames

Moderate Urban Pollution

Moderate Deicing Salt Exposure

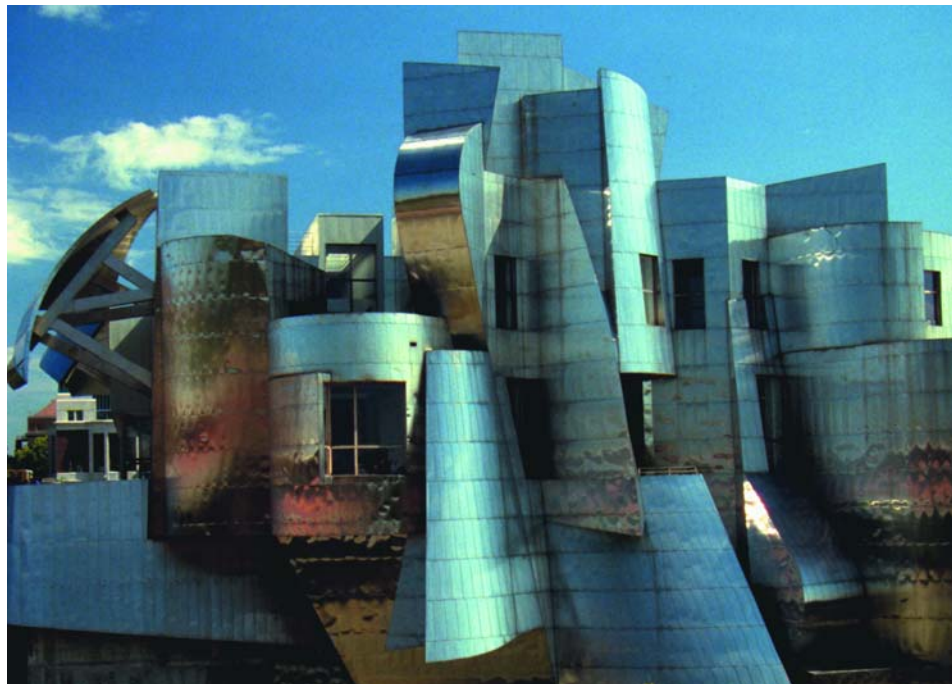
Figure A (above) Type 316 stainless steel with a smooth surface finish and a design that encourages rain cleaning was the right choice for the Weisman Art Museum. Although it is beside a busy road where deicing salt is used, there is no corrosion. The color of the building changes constantly as it reflects the surrounding environment.

The Frederick R. Weisman Art Museum in Minneapolis, Minnesota, USA adjoins a major road and bridge where deicing salts are used (**Figure A**). Frank O. Gehry, the building's architect, recognized the corrosive nature of the environment and selected Type 316 (UNS S31600, EN 1.4401, SUS 316) stainless steel wall panels (**Figure B**). Type 316 contains 2% molybdenum, which improves pitting and crevice corrosion resistance. This is particularly helpful in preventing salt damage.

The closest panels are about 4.6 meter (15 feet) from the road. A smooth No. 4 finish was specified with an average surface roughness of R_a 0.5 μm or 20 μin . During design, it was assumed that there would be little or no manual cleaning of the building. The building is cleaned about every five years to remove dirt accumulation. The design, smooth surface finish, and vertical finish grain orientation make it easy for natural rain-washing to remove salt.

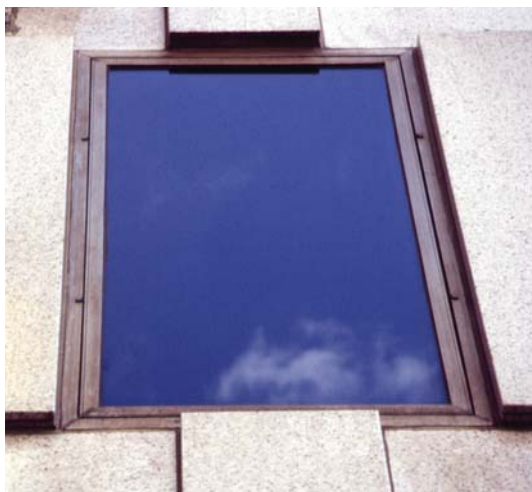
Figure C This Type 304 stainless steel window frame has not been cleaned in five years. Type 304 that is exposed to deicing salt must be cleaned regularly to remove corrosive deposits. Even with that precaution, some staining may occur between cleanings. (Photo Courtesy of the Nickel Institute)

The Type 304 (UNS S30400, EN 1.4301, SUS 304) stainless steel window frame is a few blocks away from the museum on the same busy road (**Figure C**). Both the window frame and the Weisman panel shown in Figure B have similar deicing salt exposure, are about the same distance from the road, and have smooth finishes.

When these photos were taken, it had been about five years since either the window frame or the panel was washed. The only significant differences between them are the type of stainless steel used and that the window frame is partially sheltered from rain by the surrounding closely spaced high-rise buildings.

Although the environment is identical, the appearance of these components is very different. The museum's Type 316 wall panels are in excellent condition with no corrosion and only a small amount of dirt accumulation. The Type 304 window frame is badly stained by corrosion.
