## Case Study 03 New York and Miami Light Poles

Moderate Urban and Rural Pollution  
Moderate Coastal Salt Exposure

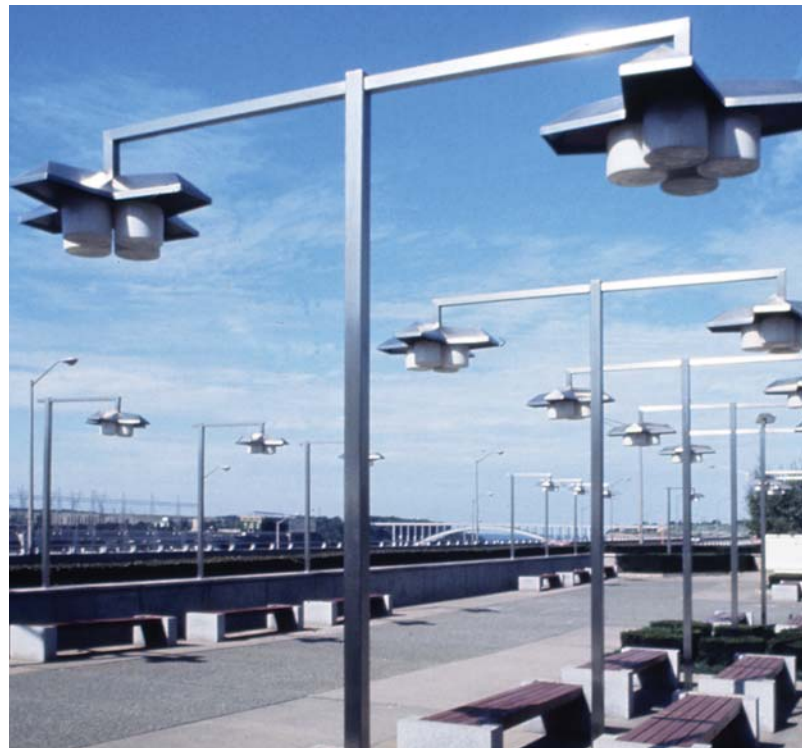
Stainless steel light fixture supports were installed at Jones Beach, New York, USA in 1967. They have a smooth No. 4 finish with a surface roughness below  $R_a$  0.5  $\mu\text{m}$  or 20  $\mu\text{in}$  (**Figure A**). Although they are in the parking area adjoining the beach and are exposed to coastal salt, there is no sign of corrosion. The park is closed during the winter and the poles are not exposed to deicing salt. They have never been cleaned but are regularly washed by rain. The poles are made of molybdenum-containing Type 316 (UNS S31600, EN 1.4401, SUS 316) stainless steel, which provides improved resistance to corrosion caused by salt and pollution.

**Figure A** Boldly exposed Type 316 stainless steel light poles with a smooth finish provide good performance in most coastal applications. (Photo Courtesy of AISI)

The light poles in Jones Beach have a smooth finish with a surface roughness below  $R_a$  0.5 µm or 20 µin and few components are sheltered. Smooth finishes retain less salt, reducing the possibility of corrosion (score -1). The Miami lights have a surface roughness above 1 µm or  $R_a$  40 µin (score +2) and are sheltered from rain-washing (score +1). Sheltered components and rough finishes generally have heavier salt deposits. If a design includes sheltered components and there is salt exposure, it is advisable to obtain assistance from a stainless steel corrosion specialist. The Kure Beach sample surface roughness is not known.

In most coastal locations like Jones Beach and Kure Beach with regular rain-washing and low to moderate pollution levels, Type 316 will retain an attractive appearance if a smooth surface finish is selected and sheltered designs are avoided. Some minor corrosion staining may occur after many years of exposure, but this can usually be removed by manual washing.

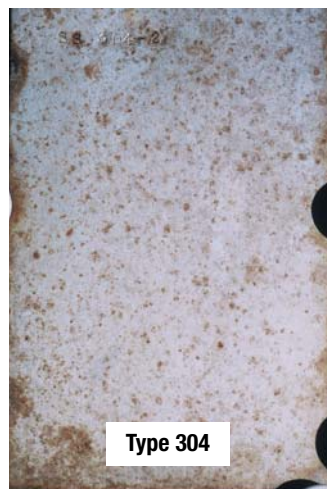
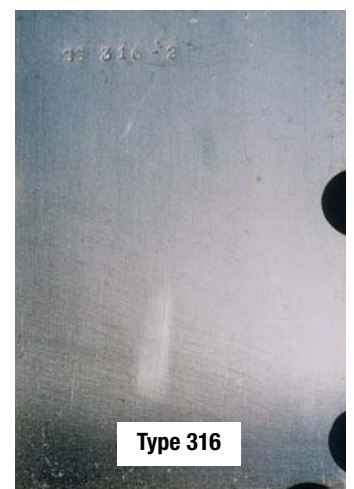
**Figure C** Kure Beach, North Carolina samples after 56 years. (Photo Courtesy of TMR Stainless)

The samples of Types 304 (left) and 316 (right) stainless steel, which are shown in **Figure C**, have a smooth finish. They were installed 250 meters (820 feet) from mean high tide at Kure Beach, North Carolina, USA. When this photo was taken, they had been in place for 56 years, and are cleaned only by rain. Some light scratching from wind blown sand is visible. The North Carolina, New York and Florida applications are about the same distance from the ocean.

The Type 316 sample has a few superficial corrosion spots that could easily be removed by cleaning but it still looks attractive. The Type 304 sample is badly stained. Like the two light poles, these samples illustrate Type 316's superior resistance to staining and corrosion in a coastal location.

Type 304

Type 316

The Miami Beach light pole component's rough finish and sheltered location make it a very corrosive application for Type 304. The Kure Beach sample shows that, even with a smooth finish and regular heavy rain-washing, Type 304 will experience corrosion staining over time in a coastal location without supplementary manual cleaning. If the sheltered design is retained and there is regular cleaning, Type 316 with a smooth finish could be considered. If less maintenance is desired, a more corrosion resistant stainless steel or a design that eliminates sheltered components should be considered.
