Case Study 06 Canary Islands Railings and Lampposts

Low Urban Pollution

High to Moderate Coastal Salt Exposure

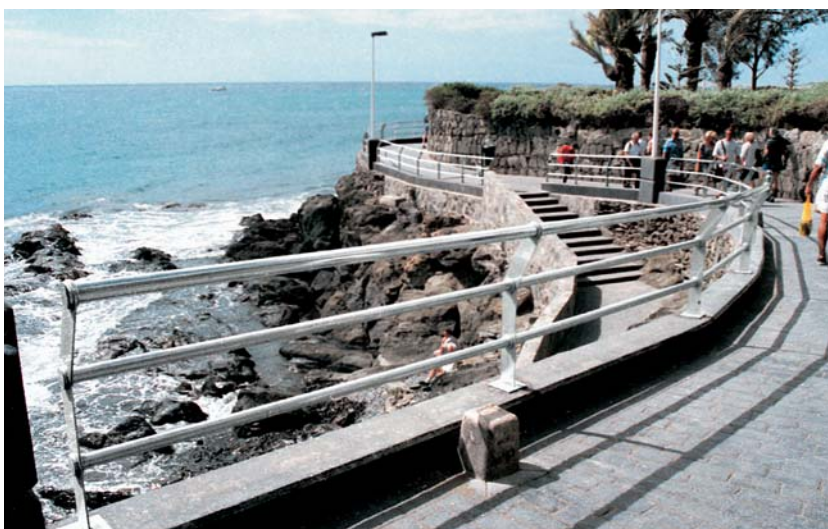
Figure A These 2205 stainless steel railings are exposed to salt spray and occasional splashing. They are in the town of San Augustin in the Canary Islands. There has been no corrosion staining despite exposure to sea spray. (Photo Courtesy of Outokumpu)

Subsequent coastal railing installations were upgraded to 2205 stainless steel, which contains more molybdenum than Type 316. They have remained attractive. **(Figure A)** The much higher strength of 2205 can be used to reduce structural section size, and this weight savings can offset the higher cost of the more corrosion resistant stainless steel.

The local weather pattern makes these locations a little more corrosive, but the most important factors in determining the scores for each application are their level of salt exposure and surface finish. The 2205 stainless steel railings are exposed to salt spray (5), a corrosive weather pattern (1) and have a smooth surface finish (-1) giving them a score of 5. If a location has a score of 5 or above, more corrosion resistant stainless steels such as 2205 should be used if corrosion staining is not acceptable and there will be no maintenance cleaning to reduce the score.

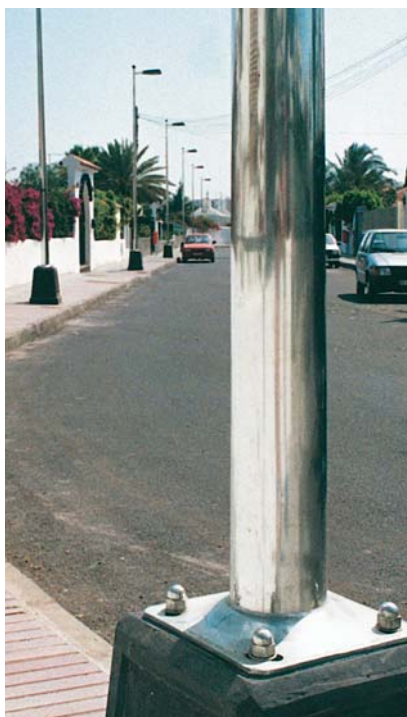
Figure B This shiny Type 316 stainless steel lamppost has been in service for over 10 years. It replaced corroding galvanized steel. (Photo Courtesy of Outokumpu)

Type 316 stainless steel with a smooth finish is usually the most cost effective choice for low- or no-maintenance applications that are exposed to coastal air but not to seawater spray or splashing. The Type 316 railings and lampposts that are not exposed to sea spray have retained their attractive appearance. **(Figure B)**

All of the applications are designed so they will be washed when it rains. The most significant design factor influencing performance is surface roughness. The Type 316 stainless steel has a smooth finish which improves its corrosion resistance. This can be seen in the mirror-like finish on the lampposts in Figure B. Either 1 or 2 points can be subtracted depending on the surface roughness.

The Type 316 stainless steel lampposts are further inland, which reduces their salt exposure (3). They are exposed to a corrosive weather pattern (1) but their smooth finish (-1) reduces their score to 3. Type 316 is generally the most cost effective choice if an application has a score of 3.
