Case Study 08 São Paulo Building Exterior

High Urban and Industrial Pollution No Salt Exposure

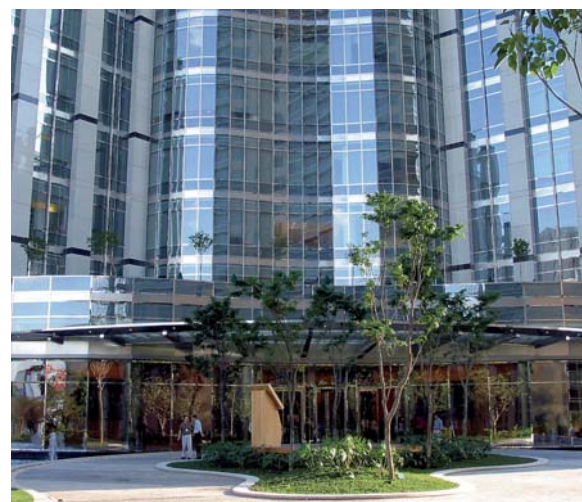
Figure B All three stainless steel finishes can be seen around the building's park-like entrance. (Photo Courtesy of Núcleo Inox)

Three different stainless steel finishes were used on the exterior. Black electrochemically colored stainless accentuates building details. A coined cambric finish was used for spandrel panels and a No. 4 polished finish was used for the entrance canopy, column covers, and other details.

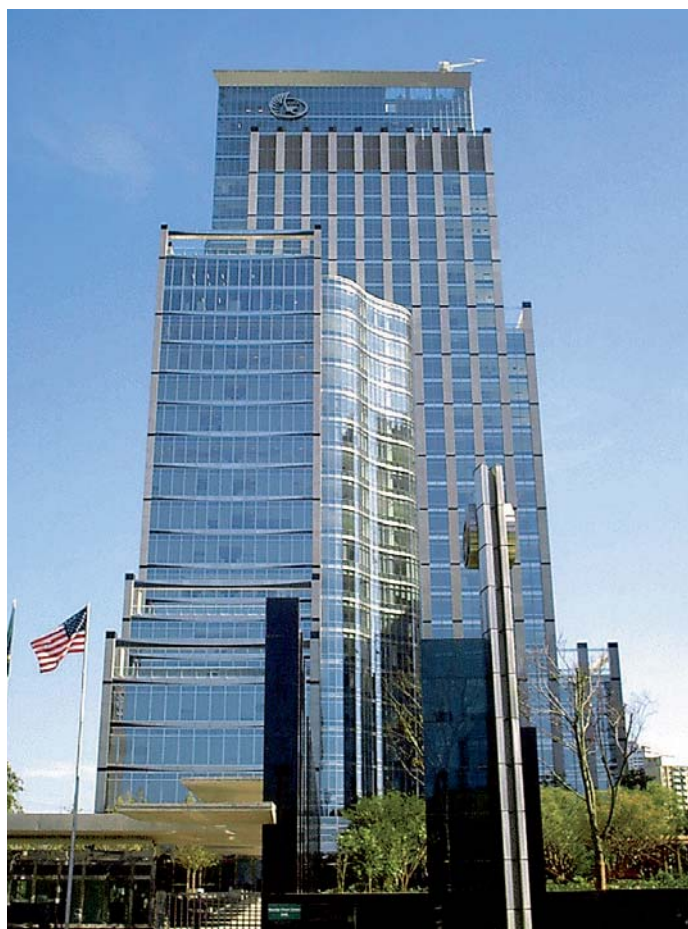
Figure A Careful stainless steel selection, design and maintenance ensure that the exterior will remain beautiful over time. (Photo Courtesy of Núcleo Inox)

Bank Boston's new South American headquarters in São Paulo, Brazil was completed in 2002. The 30-story building was designed by the international architecture firm Skidmore Owings & Merrill, LLP in conjunction with the Brazilian architecture firm Escritório Técnico Júlio Neves. **(Figures A and B)** It was designed using "green" building concepts, making material service life an important consideration.
