## Case Study 09 Australian Coastal Fence

Low Pollution Exposure  
High Coastal Salt Exposure

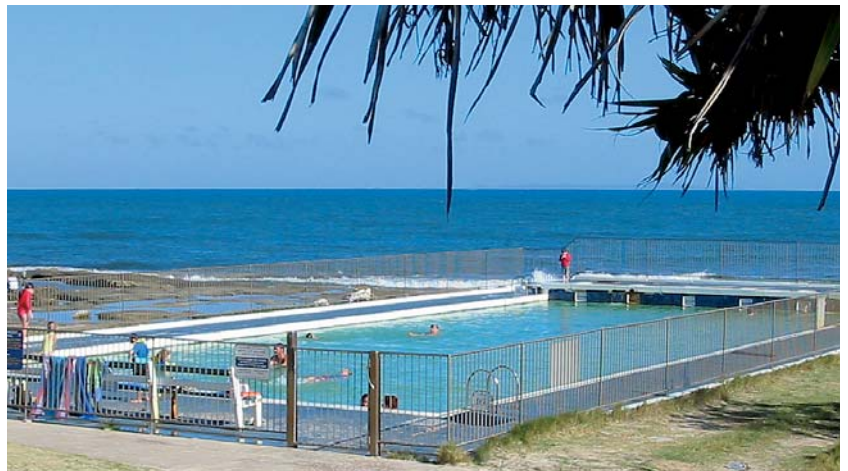
Both Type 304 (UNS S30400, EN 1.4301, SUS 304) stainless steel and Type 316 (UNS S31600, EN 1.4401, SUS 316) stainless steel were used for a fence around a sea-water swimming pool adjoining the ocean. **(Figure A)** The posts are Type 304 stainless steel and the other railing and gate components are Type 316 stainless steel. As can be seen in **Figure B**, the posts are corroding.

**Figure A** Stainless steel is used regularly for coastal applications. If properly selected, it can remain attractive and structurally sound in this corrosive environment. (Photo Courtesy of Australian Stainless Steel Development Association)

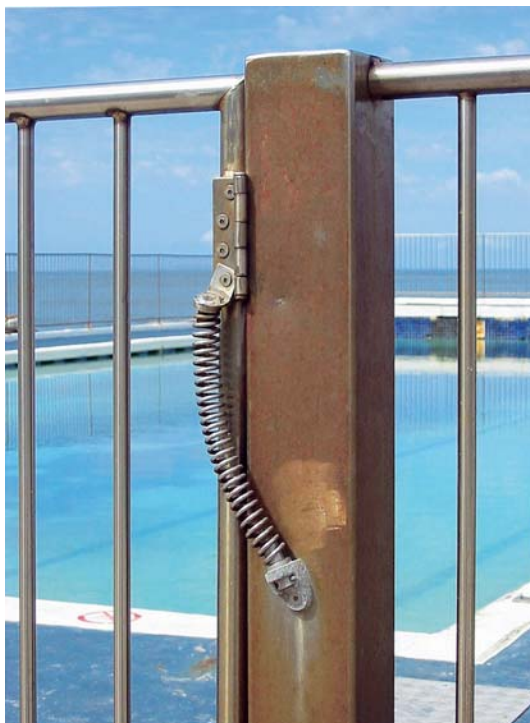
**Figure B** The contrast in appearance between the gate and support post is due to stainless steel chemistry and surface roughness differences. The corrosion-free gate is Type 316 stainless steel and the post that is discolored by corrosion is Type 304 stainless steel. (Photo Courtesy of Australian Stainless Steel Development Association)

Stainless steel is more resistant to corrosive coastal salts (chlorides) than other common architectural materials. Type 316 stainless steel is generally the most cost effective material choice for long-term, low-maintenance applications that are near the coast but not splashed or immersed in seawater. Type 316 stainless steel contains 2% molybdenum, which helps to prevent pitting and crevice corrosion caused by deposited salts. In low or no maintenance applications like this pool fence, it is also important to specify a smooth surface finish to minimize the potential for corrosion. As can be seen in **Figure B**, there is no corrosion on the Type 316 stainless steel gate and fence components.

When specifying stainless steel in a corrosive environment it is important to seal or eliminate crevices by welding and to use a design that is easily cleaned by rain. Most of the fence components were welded together which is preferred for a long-term structure. Unfortunately, not all of the welds were properly cleaned and dark discoloration (heat tint) and corrosion can be seen around some of the Type 316 stainless steel welds. Heat tint, the surface oxidation associated with the heat of welding, must be completely removed in order to restore the corrosion resistance of the stainless steel. If these welds are ground and/or pickled, they will perform as well as the rest of the Type 316 stainless steel in the fence. Heat tint does not reduce the structural properties, but it may be considered unsightly by the users of the material.

The railing is less than 30 m (100 ft) from the ocean and each section's exposure to salt water varies. The section closest to the ocean is splashed when the surf is "up". (+5) The components shown in Figure B are farther from the water and are only exposed to salt spray during storms but their close proximity to the ocean and the rough surf mean that exposure to coastal salt (chlorides) is high. (+4)

The finishes on the Type 316 stainless steel gate and the Type 304 stainless steel post are very different. The coarse post has an average surface roughness of  $R_a$  1.1  $\mu\text{m}$  (43  $\mu\text{in}$ ) which increases the score (+2). The smoother gate has a surface roughness of about  $R_a$  0.46  $\mu\text{m}$  (18  $\mu\text{in}$ ), which reduces the score (-1). Corrosive substances have to remain on a surface for corrosion to occur. Rain more easily removes corrosive salt deposits from smooth finishes. In addition, a rougher finish retains rainwater longer, extending the time of wetness when corrosion can occur.

Type 304 stainless steel is not appropriate for coastal applications unless: (1) a very smooth finish is specified; (2) there is regular cleaning; and (3) some staining between cleanings is acceptable. The Type 304 stainless steel fence post corrosion should have been anticipated. The problem was made worse by the very rough finish, which retained corrosive salt (chlorides) and accelerated the corrosion rate. A much more corrosion resistant stainless steel would have been necessary for corrosion-free performance with this rough finish. Although there is corrosion over the entire surface, it is superficial and structural failure is unlikely during the pool life, since it will corrode about 1,000 times more slowly than carbon steel.

A score of 3 means that Type 316 stainless steel is generally the most cost effective choice, so it is not surprising that the gate and most of the Type 316 fence components have remained attractive without maintenance. Type 316 stainless steel performs well in most coastal, low-to-moderate pollution environments as long as smooth surface finishes are specified and regular heavy rains remove surface deposits. Without maintenance, some light staining may occur over time, but it is easily removed. Unless there is regular cleaning, Type 316 stainless steel will corrode if it is regularly sprayed or splashed with salt water. This is why the fence section immediately adjoining the water has a score of 4.
