# Better service lines with moly

Almost nothing is more important than water. Yet, water transmission systems worldwide lose billions and billions of liters of water a year to leakage. The solution to reducing this leakage is multifaceted but replacing existing service lines with molybdenum-containing stainless steel has proven highly successful.

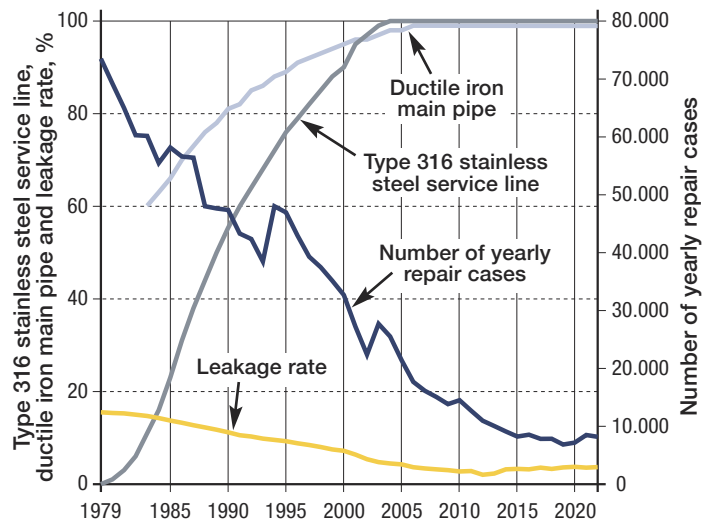
Repair cases and leakage rate in Tokyo (source: TBWW).

More than 40 years since the project began, and with 100% of the service lines under its jurisdiction replaced with Type 316 stainless steel by the early 2000s, Tokyo has massively reduced leakage and maintenance needs. Together with ductile iron mains, leak detection, and rapid repair techniques, the leakage rate decreased from 15.4% in 1980 to 3.7% in 2022. Most of the remaining leaks are caused by tubes of other materials, for example, under private roads, where TBWW did not have the

jurisdiction to install stainless steel lines. Overall, Tokyo documented a 90% reduction in repair cases since 1979, saving hundreds of millions of USD annually.

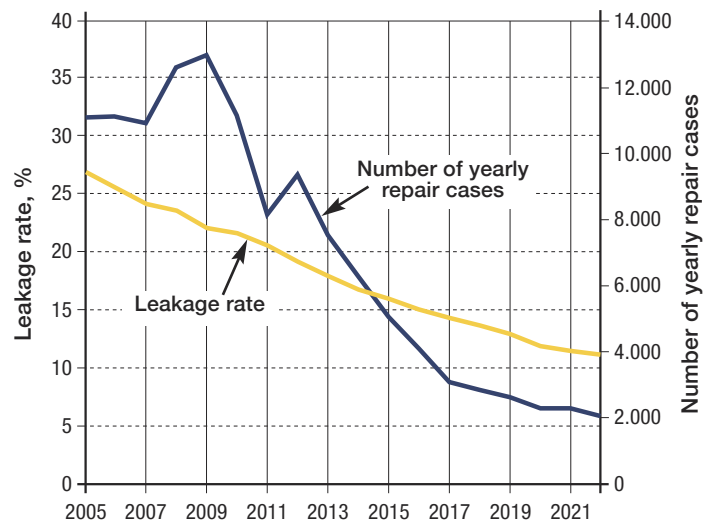
Repair cases and leakage rate in Taipei (source: TWD).

Taipei's system leaked 28% of its water at the time. Looking for ways to increase its resilience, the Taipei Water Department (TWD) trialed stainless steel service lines,

given their superb performance in several Japanese cities and Seoul, South Korea. Following successful testing, the utility began installing SPCT in 2006 as part of a 20-year leakage reduction project. As of 2022, with 2/3rds of the system replaced with stainless steel service lines, leakage has more than halved to 11%. When a more severe drought overcame Taiwan in 2014, Taipei had no disruption to service, and TWD could even sell surplus water to their neighboring utility. Additionally, over the past four years, TWD had on average only 20 leakage cases/year related to the nearly 200,000 stainless steel service connections installed by now, an order of magnitude fewer than typical with competing materials.

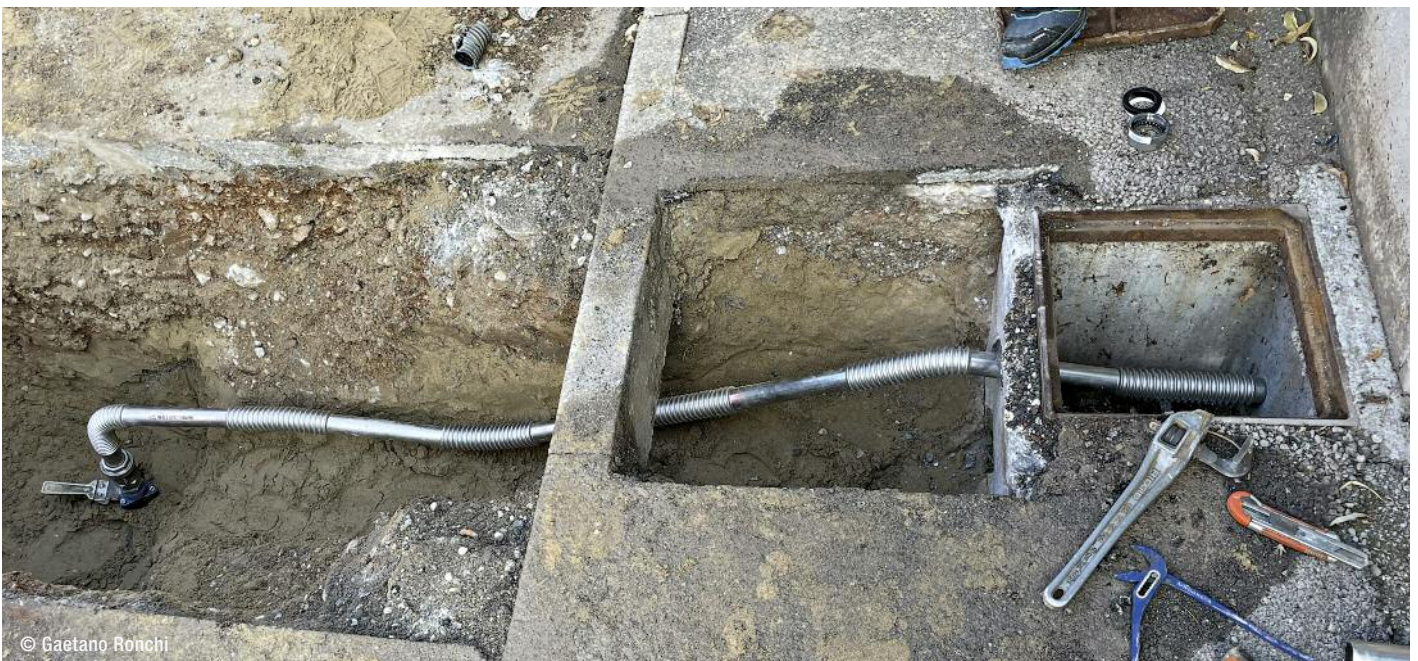
### ➤ A trial installation in Italy.

Over the last year, six Italian water authorities have tested SPCT and four utilities are currently evaluating the next step: "proof of concept" trials with several hundred SPCT connections. A supply chain is in place to service the market initially with imports until the demand is high enough for local production. Indeed, CPC Inox, the prospective Italian SPCT producer, received the BFWI Innovation Award for Materials at the H<sub>2</sub>O trade fair in Bologna this fall.
