Stainless steel stops leaks

Repair sleeves are found in the tool box of virtually every water utility. They allow quick repair of leaking water pipes without replacing them. Often fabricated from molybdenum-grade Type 316 stainless steel, they reduce water wastage and are yet another way that molybdenum helps sustain Earth’s resources.

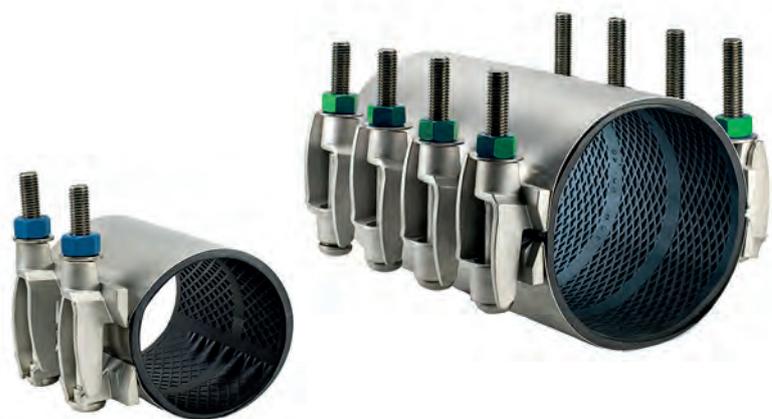
Type 316 stainless steel repair clamps are used to stop pipe leaks without replacing lengths of pipe. © JCM Industries, Inc.

the leaking pipe instead of welding or threading a replacement section. It is like a Band-Aid® wrapped around one's finger. Here, a 304 or 316 stainless steel band with an attached rubber gasket is fastened around the pipe, over the damage. Tightening the clamp, or sleeve, applies more sealing pressure on the exterior of the pipe than is on the interior, stopping the leak.

The sleeve's metal component is almost always stainless steel, most commonly Type 304 because it is compatible with many soils. However, when soil corrosion is a concern, molybdenum-containing Type 316 is specified because it is very

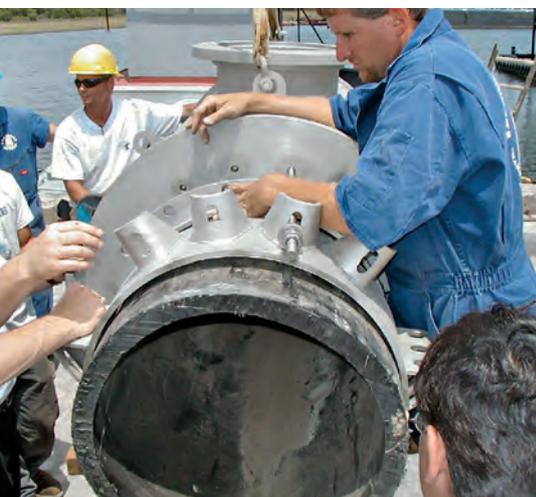
Technicians are reviewing the steps required to install the sleeve correctly. © Charleston Commissioners of Public Works

Some manufacturers provide engineering and fabrication services for custom-made sleeves for critical applications. One supplier, for example, undertook a very difficult underwater repair of a failed 610 millimeter diameter HDPE plastic pipe for the city of Charleston, SC. This 4.8-bar water main failed at a fusion joint on the harbor bed under 7.5 meters of water.

Initially, the Charleston Commissioners of Public Works made a repair using a stock Type 304 sleeve and coated carbon steel restrainer. However, for a

permanent solution, the authority desired a more robust sleeve that would support high stresses on the pipe and assure good long-term performance. They asked the fabricator to engineer and build a new sleeve to completely encapsulate the repair sleeve, and to build a restrainer to relieve stresses on the extending plastic pipe. In addition to designing and fabricating the new Type 316 sleeve, the project specification included a dry run to test the anticipated difficult installation under 7.5 meters of water. The new sleeve was installed in 2004 and has performed very well, with no problems reported to date.

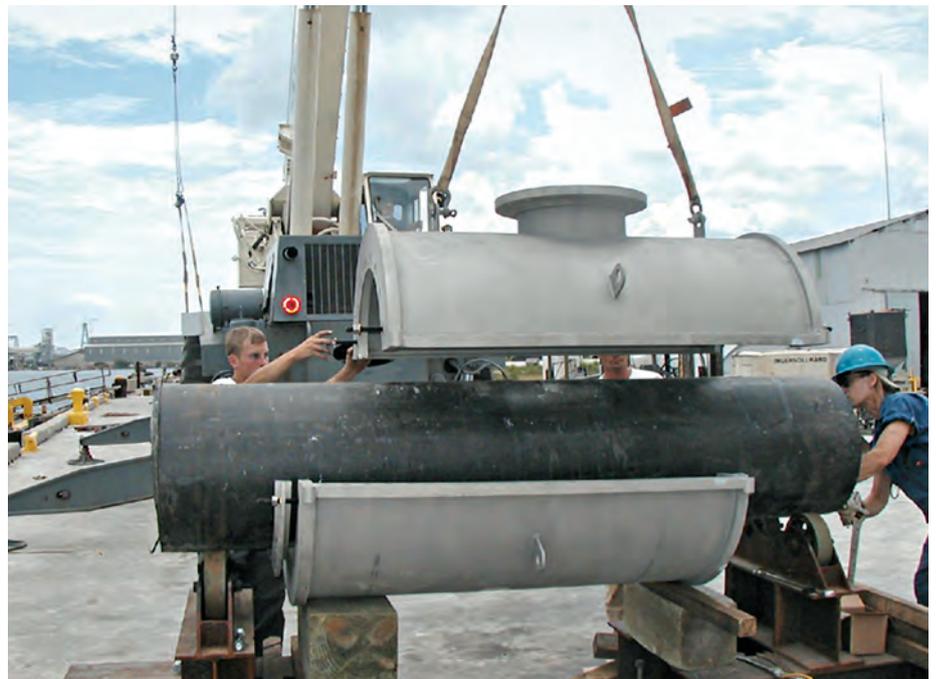
"Mock" installation of a custom-fabricated Type 316 stainless steel repair sleeve. The technicians are practicing the underwater installation on a piece of pipe in the dry. © Charleston Commissioners of Public Works
