Saving Fallingwater

What was intended to be a weekend retreat for a wealthy Pittsburgh department store magnate and his family, “Fallingwater” now stands as one of the most iconic tributes to architect Frank Lloyd Wright. Molybdenum-alloyed Type 316L stainless steel plays a small but crucial role in preserving one of the greatest buildings of all time.

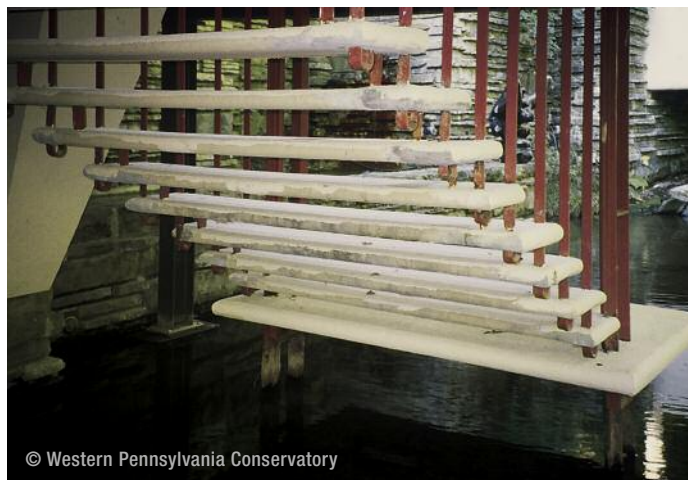
➤ Over the years corrosion weakened the structural steel of the famous staircase.

The mild carbon steel used in the original tread hangers of the "hatch" stairs corroded over years of exposure to the moist environment. At times, the staircase would become partially submerged during flood conditions. It also acted as a trap for flotsam and jetsam, adding additional stress to the steel supports. At one point, during a violent storm in the 1960's, the staircase was torn from the structure and had to be replaced.

To prevent the future weakening of the structure from corrosion and the forces of debris-filled storm water, restoration architects replaced the stair hangers and the reinforcement within the concrete treads and landing with molybdenum-alloyed Type 316L stainless steel. The same stainless steel was also chosen for the replacement of the structural columns at the landing that support the east terrace, which can be submerged in the stream after

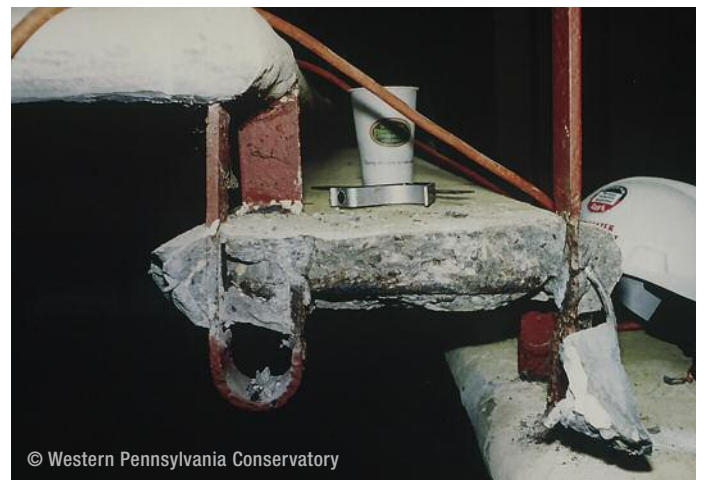
➤ Close-up image of severely corroded steel hangers and concrete deterioration.

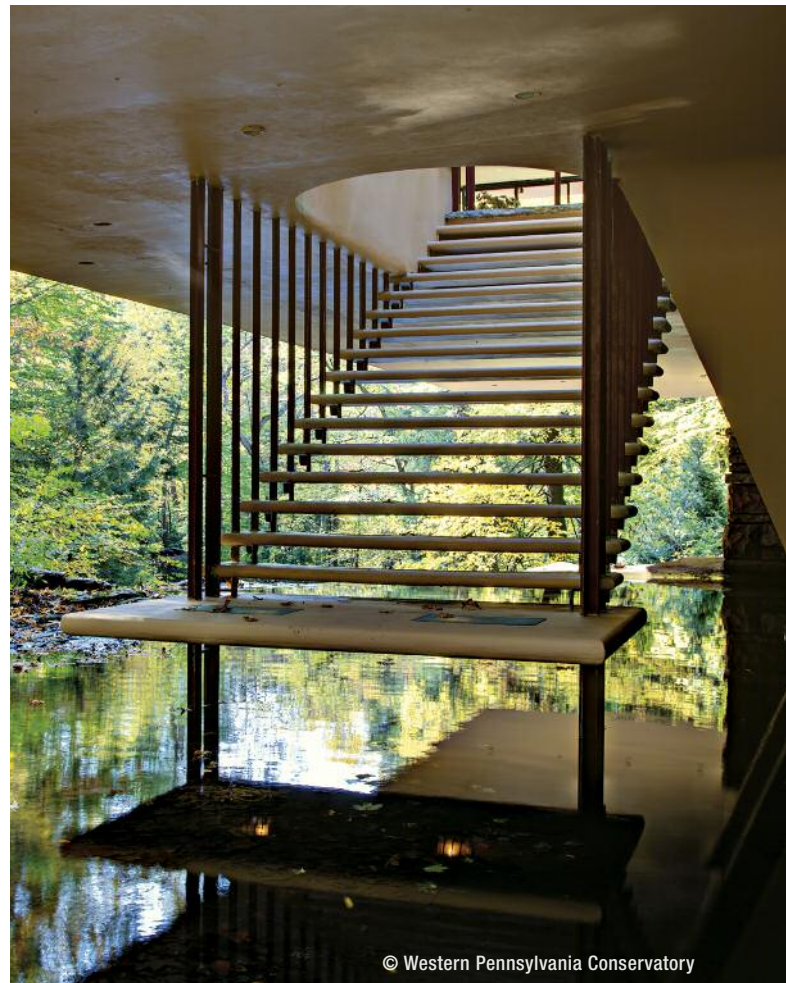
➤ Fully-restored "hatch" staircase over Bear Run.

heavy rains. An additional benefit of this alloy is its' impact resistance to flooding debris. A specially formulated "Cherokee Red" paint that Wright claimed reflected both the color of iron ore and the fiery process used in steel-making was applied to blend the new stairs with the existing construction.
