Resurrecting St. Mary's Cathedral

In a city where Shinto shrines and Buddhist temples abound, a Catholic cathedral is an unexpected sight. Nonetheless, Tokyo's St. Mary's Cathedral is one of the world's most famous churches. Designed in the early 1960s by master architect Kenzo Tange, its stainless steel-clad shape was ahead of its time – both in terms of its architecture and of the available technology of the day. To fix some of the resulting problems, the cathedral was re-clad after 40 years with a molybdenum-containing ferritic stainless steel certain to last a lifetime.

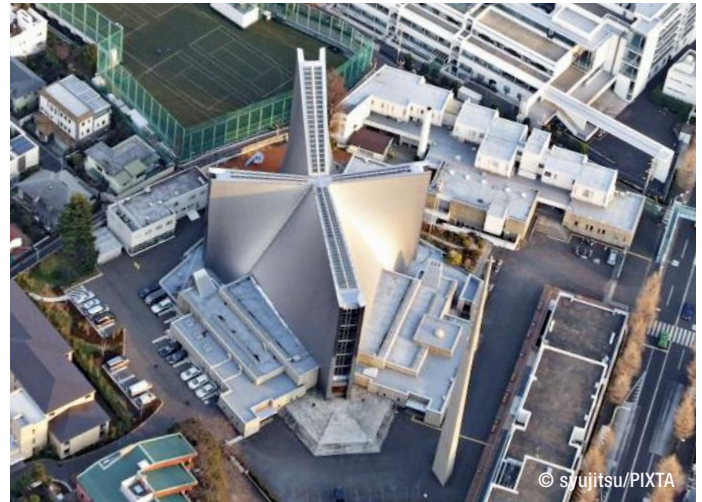
- St. Mary's Cathedral has the shape of a cross viewed from above. The bell tower at the bottom sits apart from the main building.

airiness of the church betrays its dense concrete and steel constitution. The church's eight faces serve as both wall and roof, curving like hyperbolic parabolas to form a cross from above. The cross-shaped skylight roof allows natural light to enter the dark concrete interior of the church, symbolizing the light of Jesus Christ.

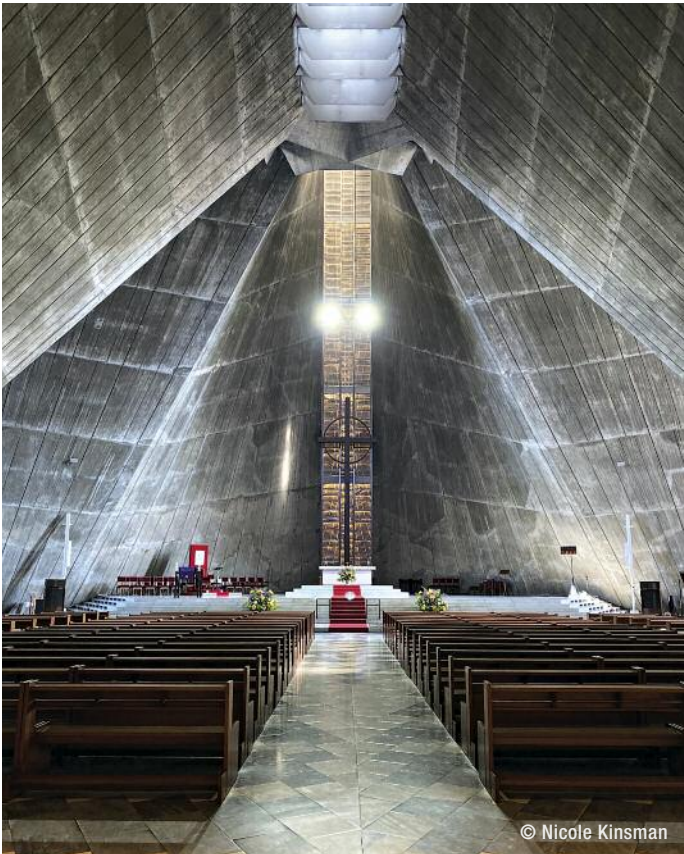
➤ The raw, unfinished texture of the church interior invokes *wabi-sabi*, a Japanese concept honoring the beauty of transient and incomplete things.

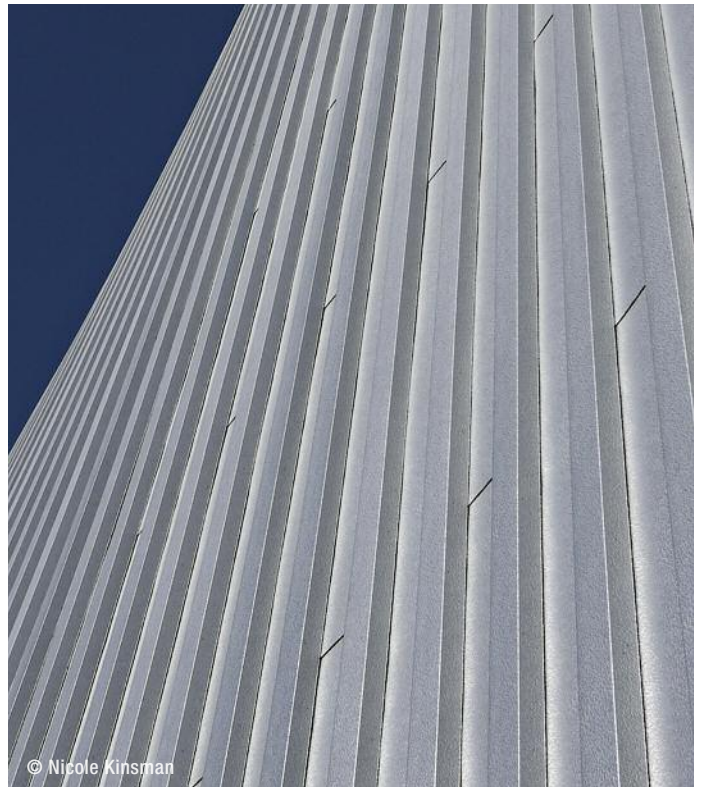
➤ The new façade uses a classic Japanese large batten roof design, developed specifically for ferritic stainless steels. The vertical battens follow the curvature of the structure and emphasize the skyward reaching of the building.

Ferritic stainless steel was chosen for the cladding, because of its lower coefficient of thermal expansion compared to austenitic stainless steel. That means ferritics don't expand and contract as much with temperature changes, making them particularly well suited for many roofing applications. Depending on the design, such thermal movement of the metal can cause high stresses in the connections and can lead to unsightly warping.

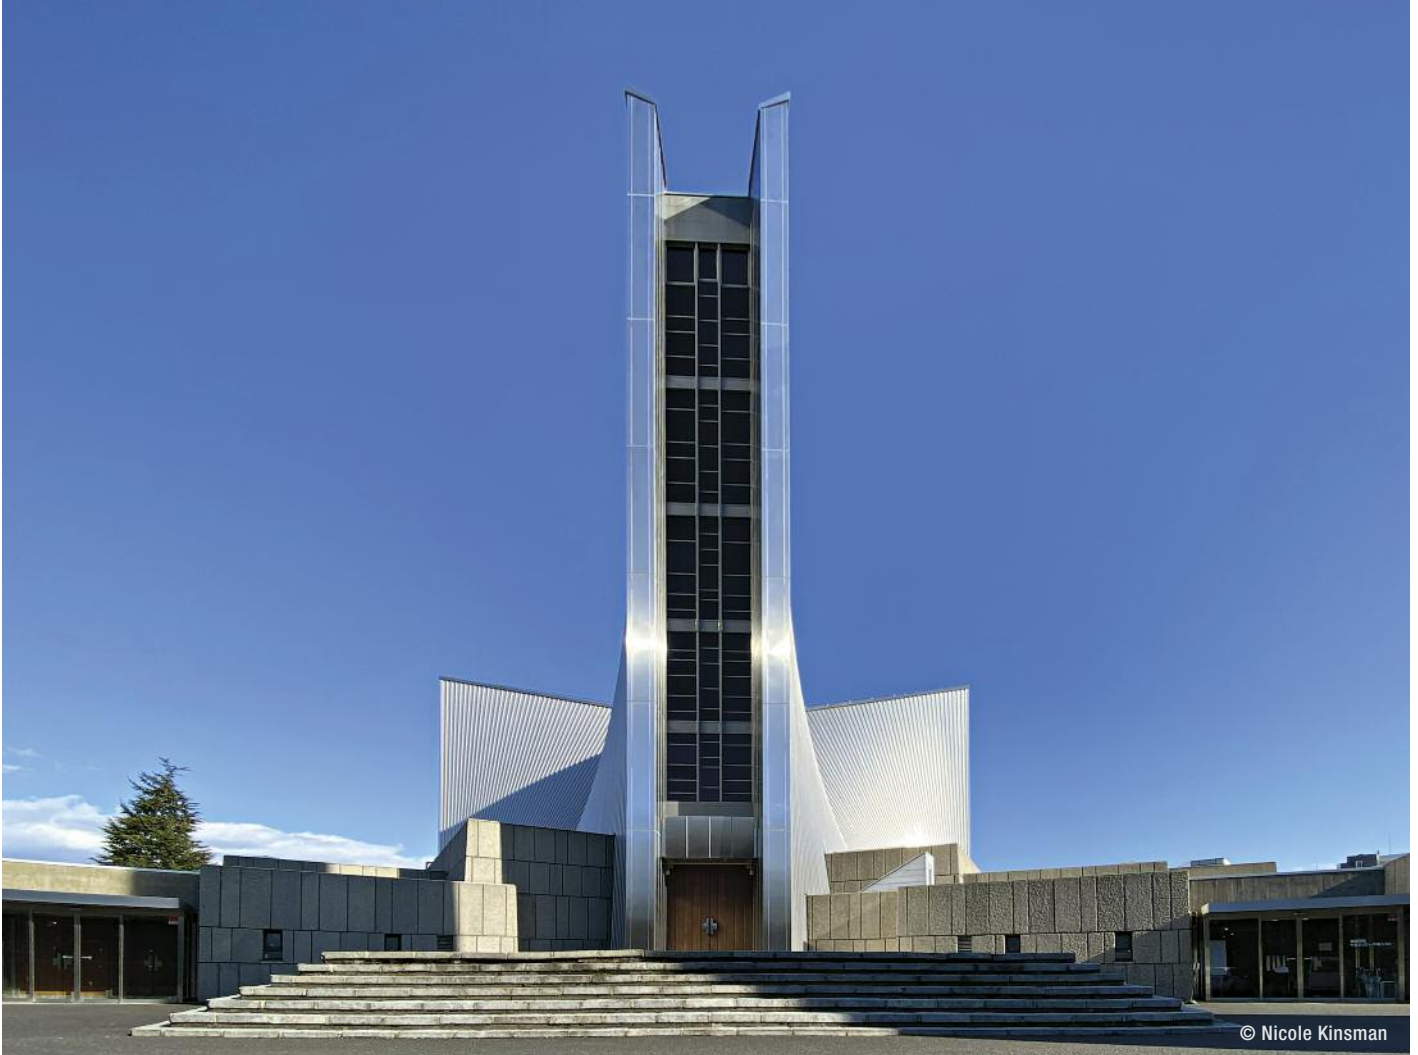
- The roof skylights extend to vertical glass walls on all four endpoints of the cross. Behind the central glass column above the main entrance sits a magnificent custom organ, the only one of its kind found in Japan outside a concert hall.

To maintain the safety and integrity of St. Mary's, both its exterior wall cladding and supporting iron structure were replaced. Ensnared in labyrinths of scaffolding, workers carefully stripped the cathedral down to its concrete skeleton, which was then cleaned and rainproofed. A special joining method allows for air to flow between the new stainless steel cladding and the inner concrete layer. This air flow dries out any moisture. The restoration and advances in glazing technology also made it possible to reopen the skylight, now constructed from glass and aluminum.

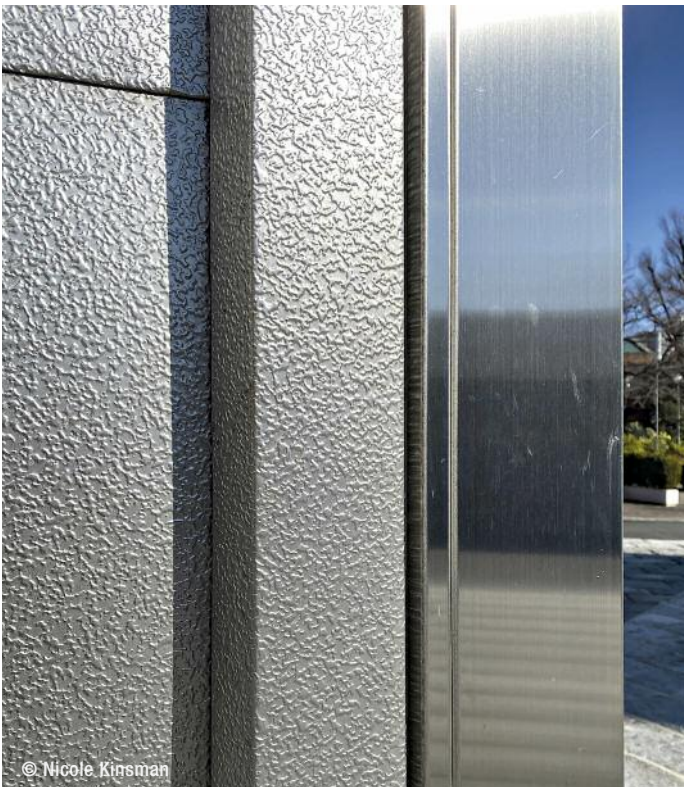
- Molybdenum helps improve the corrosion resistance of the deeply-textured surface finish used on most of the church.

The Type 445J1 alloy used here contains around 1% molybdenum. Adding molybdenum to ferritic stainless steels improves their resistance to localized corrosion in challenging environments. Tokyo is coastal and often humid, so molybdenum is key to preserving the cladding's look and service life. Furthermore, the stainless steel cladding features a smooth, rolled-on patterned finish, also contributing to its corrosion resistance. This finish creates a more consistent appearance by diffusing light more effectively than the original flat finish. This provides a certain uniformity to the surface, hiding any oil canning or uneven spots. Importantly, modern stainless steel roof finishes like the one on St. Mary's reduce reflectivity, sparing drivers, pilots and pedestrians from glare.
