# Cost-saving super duplex

The quantifiable benefits of stainless steel are often future-oriented, namely reducing maintenance throughout service life and reducing life cycle costs. But stainless steel, especially the strong duplex grades, sometimes emerges as the most affordable option from the initial investment! The following case study discusses how a 2507 super duplex stainless steel exhaust stack replacement option was less expensive than a weathering steel alternative.

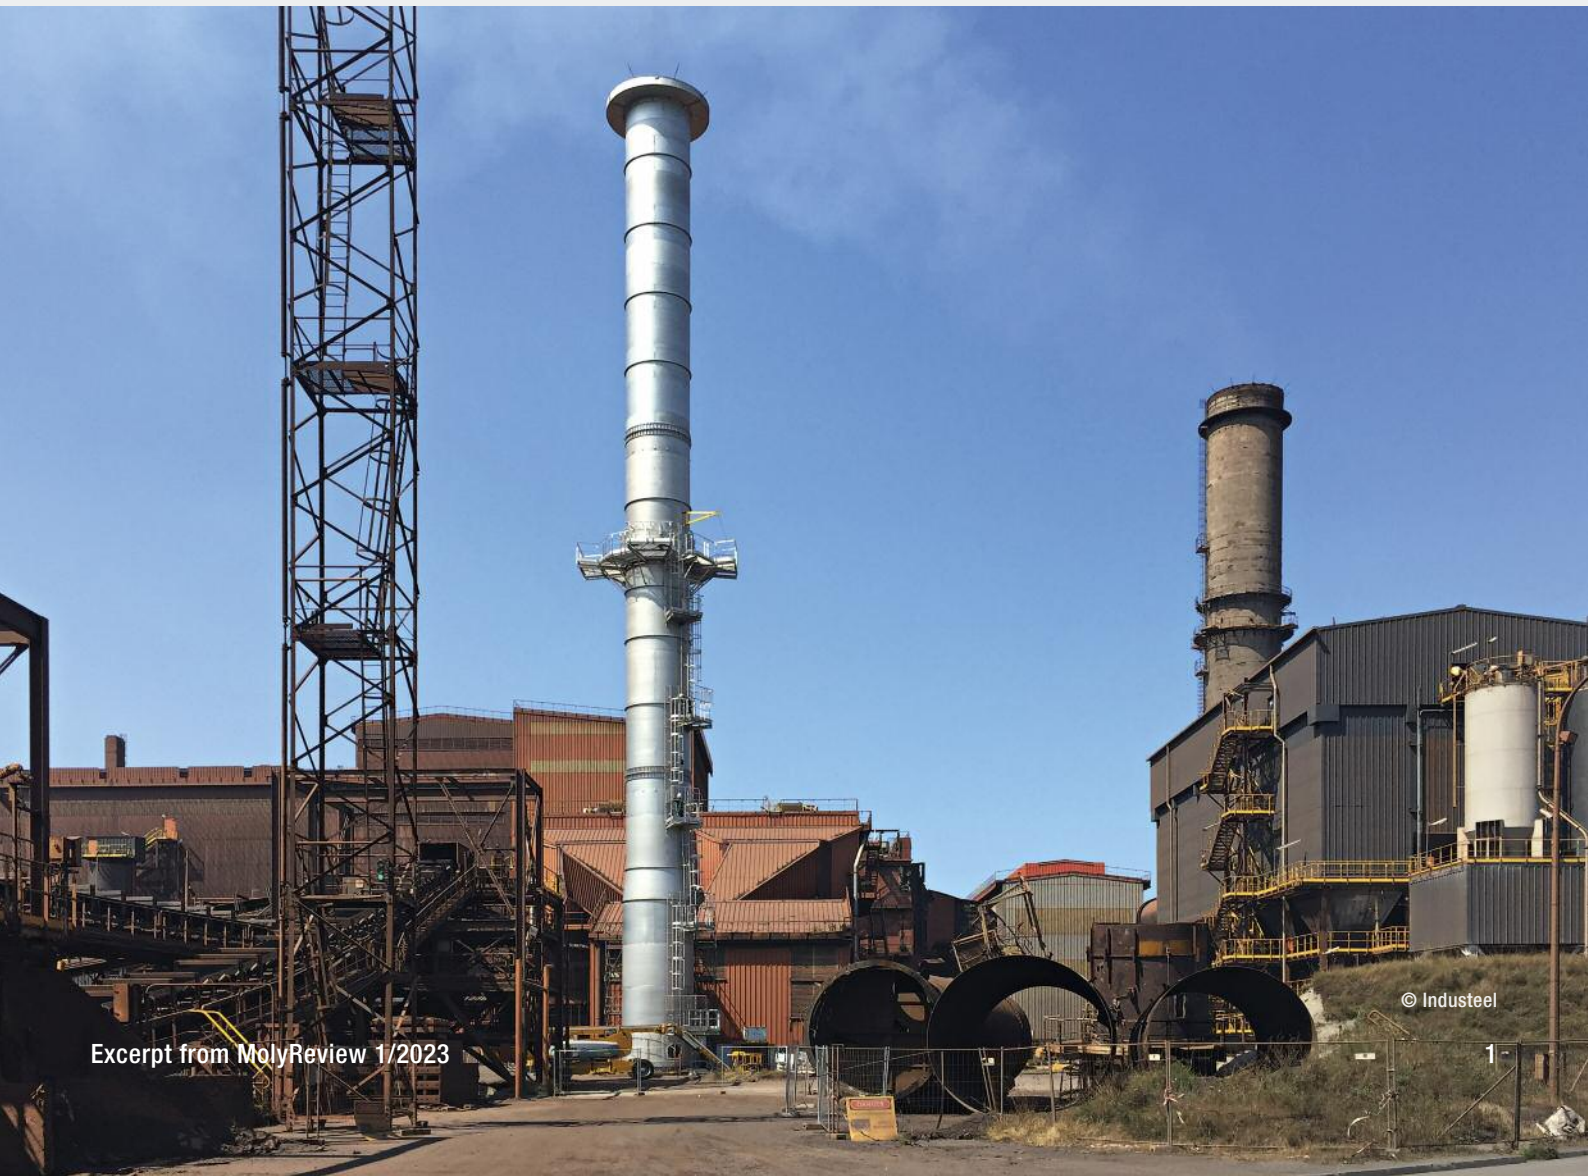
➤ Reddish-brown deposits of iron ore dust from the processing plant have accumulated over the years on the stack surfaces, but thanks to the excellent corrosion resistance of super duplex stainless steel, they will not cause any deterioration of the stack.

Since installation, the stack is issue-free and should continue to provide low maintenance service for the next 30 years and beyond. This case study exemplifies how the advanced strength and corrosion resistance of duplex stainless steels often enable not only weight savings but immediate cost savings. Stainless steel is also one of the most highly recycled materials on earth – therefore, at least a portion of the initial investment can be recouped at the end of service life as scrap value. Given full consideration for its service life and maintenance needs, what seems like a luxury material sometimes proves to be the most affordable option. (Jim Fritz)

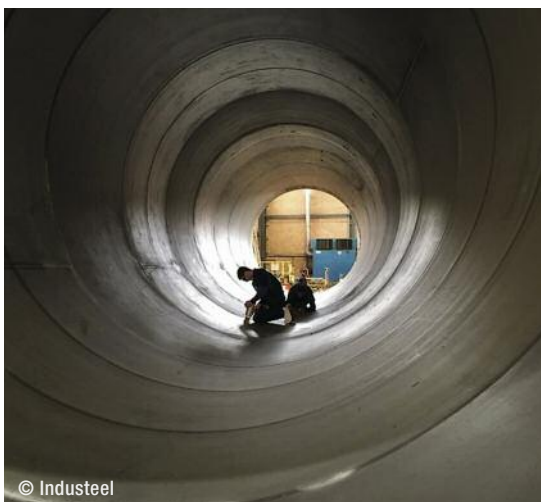
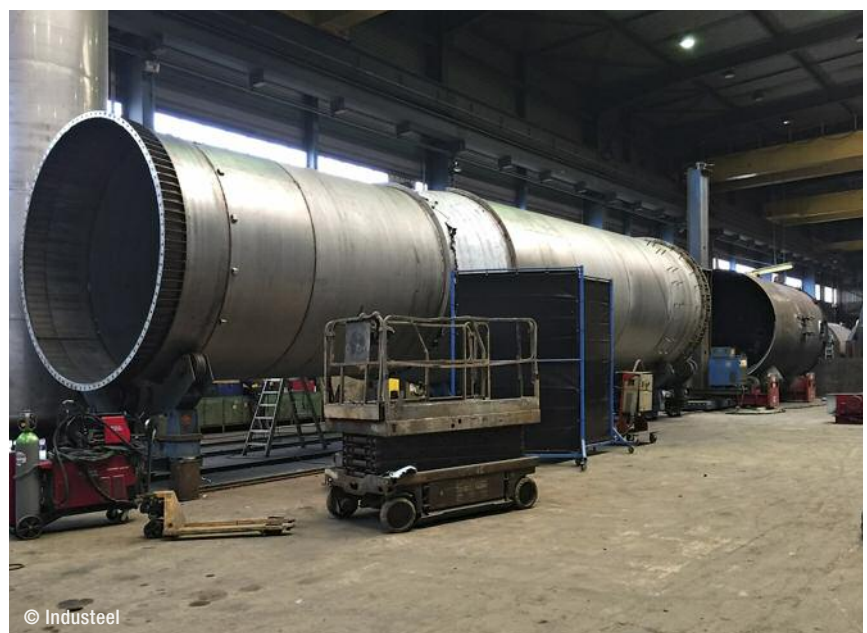
➤ Work on the 2507 super duplex stainless steel stack sections in the fabrication shop.

The stack was replaced using 6 mm to 10 mm thick plates that were cold formed and seam welded into massive rings. These were joined at the fabricator to create stack lengths that could be shipped to the job site for erection. Like a giant ring tower, each round section of welded plate was placed atop the next using a gargantuan crane. The replacement stack was completed and put into service in the summer of 2019.

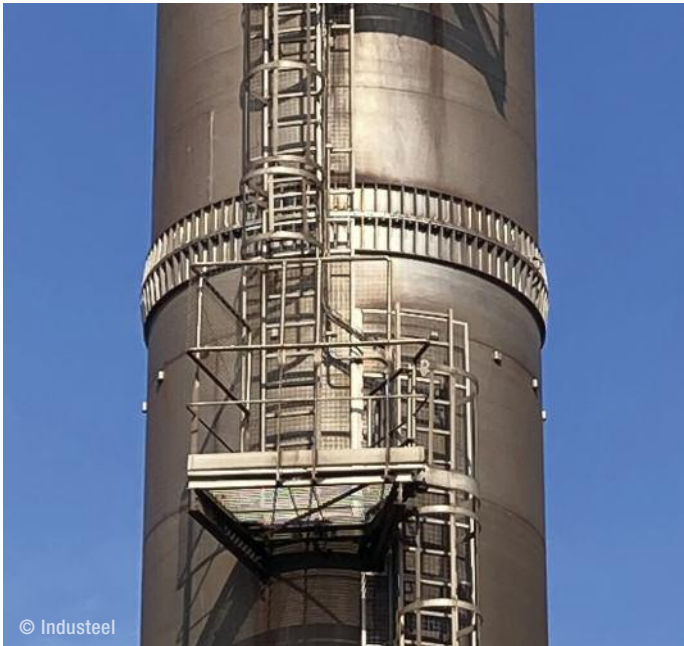
➤ The stack was shipped in segments that were bolted together on site. Ladders and platforms are directly attached to the self-supporting wall. This is much simpler than anchoring them through the outer skin and the thick insulation to the structural inner wall in a double wall system.
