Case Study 12 Milan Building Exterior

Moderate Industrial Pollution Exposure
No Salt Exposure

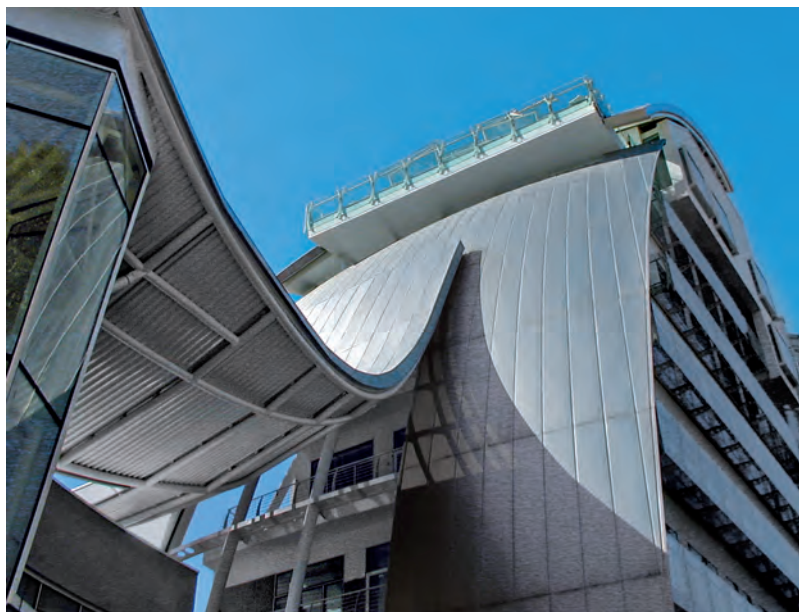
Figure A The new office building has a perforated, seven-story Type 316L stainless steel "sail" that also serves as a sunscreen. Photo courtesy of Centro Inox.

In 2004, the new addition was completed on the south side of the original building. A seven-story Type 316L (UNS S31603, EN 1.4404, SUS 316L) stainless steel sail covers one side of the new building and functions as a sunscreen to minimize building heat gain. Types 316 and 316L provide equivalent corrosion resistance. Type 316L has lower carbon levels and is preferred for welding. **(Figure A)**

The stainless steel was perforated to create sunscreens. The edges of perforations are often rough, retain more corrosive deposits and are not effectively rain-washed. This increases the likelihood of corrosion unless there is manual washing to remove deposits. Types 316 and 316L stainless steels, containing 2% molybdenum, were selected for the project. They provide good resistance to the crevice corrosion that can occur under surface deposits, and they were needed because of the high particulate levels, the probable lack of manual cleaning, and the presence of perforations. Both Types 316 and 316L have performed well.

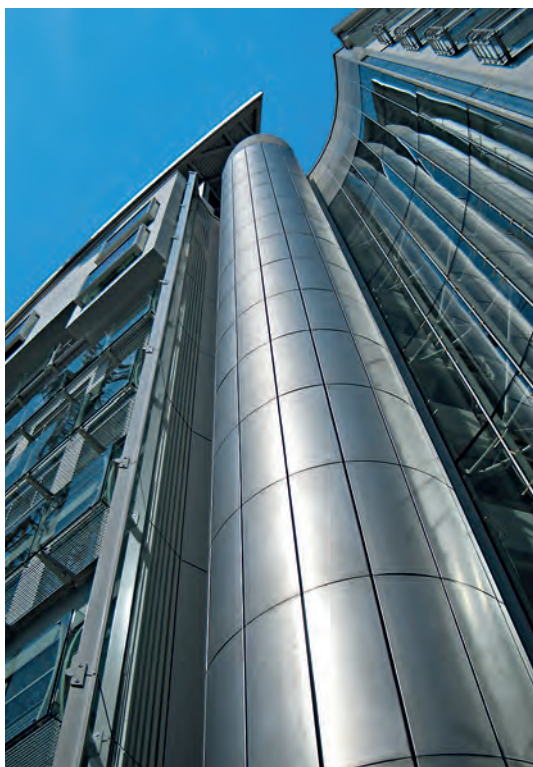
Figure B Type 316L stainless steel covers the columnar elevator shaft at the point where the buildings were joined. Photo courtesy of Centro Inox.
