Case Study 01 Pittsburgh and Chicago Handrails and Street Furniture

Moderate Urban Pollution

High to Low Deicing Salt Exposure

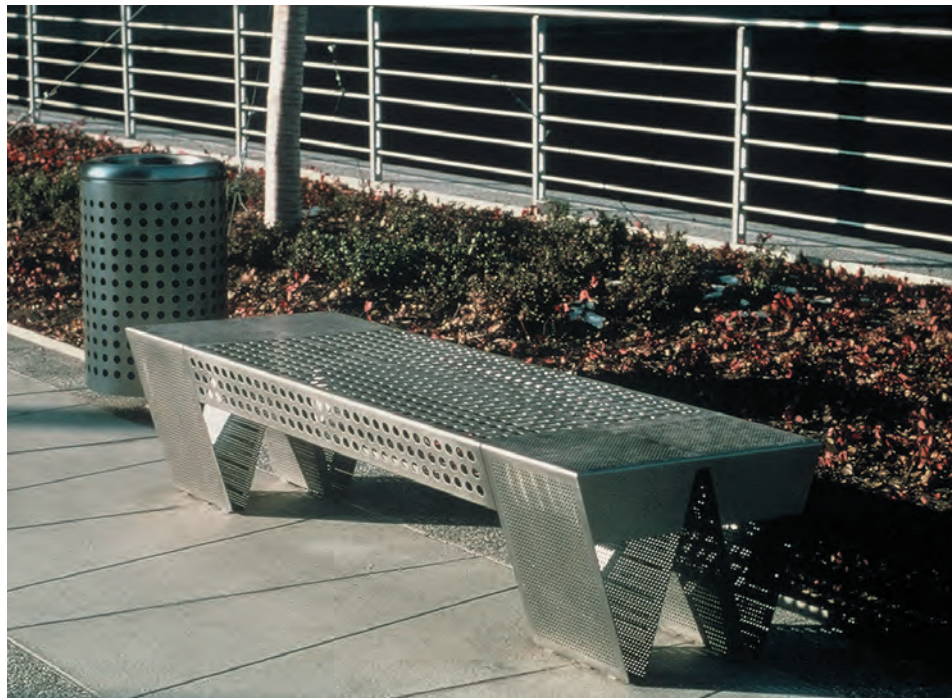
In downtown Chicago, Illinois, USA, this Type 316 (UNS S31600, EN 1.4401, SUS 316) stainless steel bench and handrail are in pristine condition after five years of service (**Figure A**). The handrail is adjacent to a sidewalk and about 1 meter (a few feet) from a busy road where deicing salt is used. The bench is in an adjoining park.

Type 316 contains 2% molybdenum, which improves pitting and crevice corrosion resistance. This is particularly helpful in preventing salt damage. The use of Type 316, a smooth surface finish, and natural rain and maintenance cleaning keep this street furniture attractive despite the severe environment.

Figure A Specification of Type 316 stainless steel, a smooth finish and a design that takes advantage of rain washing keep this bench and handrail beautiful. (Photo Courtesy of Paul Pittsford)

In both designs, crevices are sealed and the designs generally encourage rain-washing. The Chicago benches have some sheltered areas and the railings have some horizontal surfaces. The smooth finish in Chicago retains less salt and it is more easily washed off by rain, but this advantage does not help in the sheltered areas under the benches where corrosive deposits can accumulate giving them a higher score. Salt adheres to the rough finish ($> R_a$ 1 μm or 40 μin) in Pittsburgh and rain cleaning is less effective. This increases the score. A smooth finish is defined as a surface roughness that is less than or equal to R_a 0.5 μm or 20 μin .

The Chicago application is washed annually after the last snowfall to remove salt deposits. The railings in Pittsburgh had not been washed since their installation the previous year when this photo was taken.

Type 316 is usually the most cost effective solution for street level applications where deicing salt is used, particularly if a smooth surface finish is specified and salt deposits are washed off manually after the last snowfall of the season or if heavy rains can wash the surface. The Chicago bench and railing scores differ in two of the evaluation categories above but both have a total score of 3 making Type 316 an appropriate material choice.

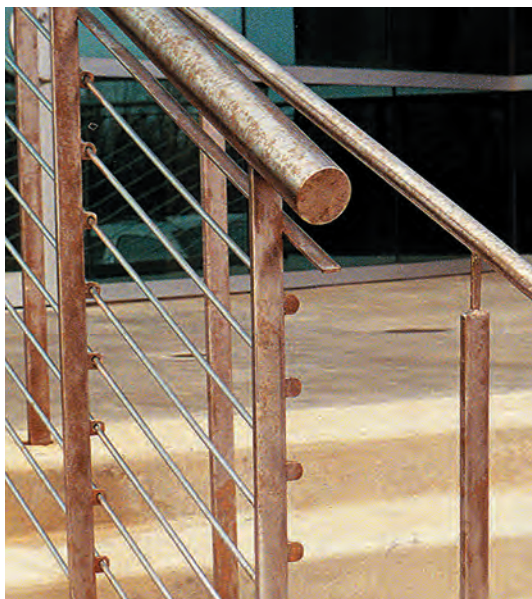
Figure B Type 304 stainless steel with a rough finish was the wrong choice for handrails exposed to deicing salt laden road mist. Cleaning will remove the staining but it will reappear every year. (Photo Courtesy of TMR Stainless)

In contrast, Type 304 (UNS S30400, EN 1.4301, SUS 304) stainless steel handrails were corroded and badly stained after only one winter in Pittsburgh, Pennsylvania, USA (**Figure B**). The railings were installed the preceding autumn. Type 304 does not contain molybdenum and is therefore more susceptible to chloride corrosion than Type 316.

The railings are located approximately 90 meters (300 feet) uphill from a busy highway. No deicing salt was used on the steps beside the railing. Wind has carried road mist, laden with deicing salts, up the hill and, deposited it on the railings.

The tubing was purchased with a mill finish. During fabrication, a coarse abrasive pad was applied to the surface producing a rough, directional, brushed appearance. The same procedure was used for the bar. Only the small diameter rods have a smooth finish which is why they have significantly less corrosion.

Salt and corrosive pollutants more readily adhere to rough surfaces and even regular heavy rain may not completely remove deposits. The use of rough surface finishes increases the probability of corrosion damage.

Type 304 will stain and corrode when exposed to deicing salt. Refinishing the railing to obtain a smooth finish which minimizes deicing salt accumulation ($\leq R_a$ 0.5 μm or 20 μin) could reduce the Pittsburgh score to a 2, indicating that 304 can be considered. Alternatively, the railing could be cleaned regularly. Even with a smoother finish, there may be some corrosion staining of Type 304 over time and occasional cleaning may be required. If airborne dust in the warmer months contains measurable salt levels, more frequent cleaning may be necessary.
