Case Study 02 Minneapolis Exterior Wall Panels and Window Frames

Moderate Urban Pollution

Moderate Deicing Salt Exposure

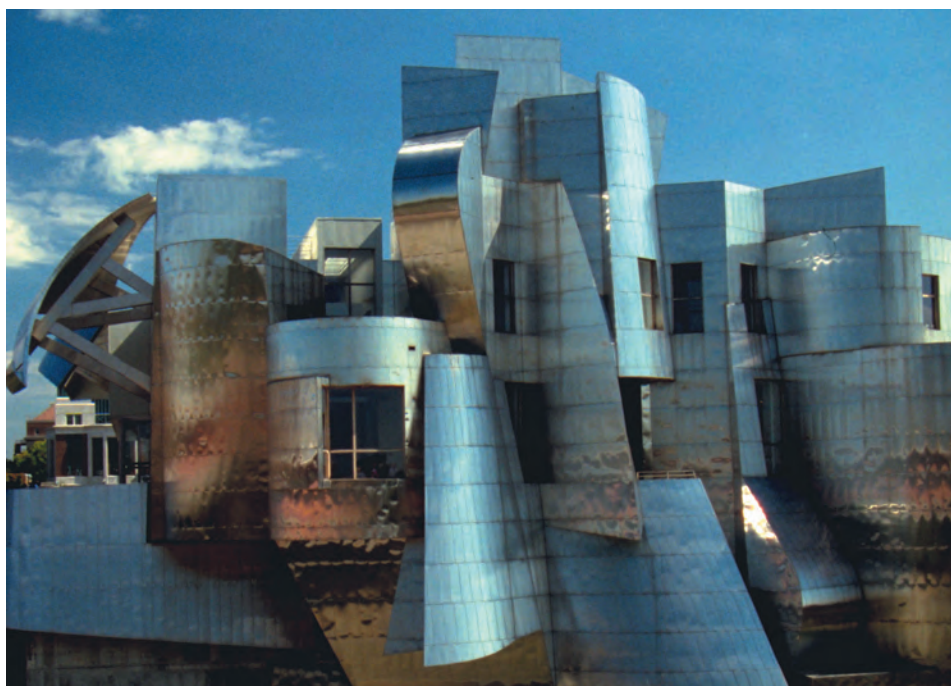
The Frederick R. Weisman Art Museum in Minneapolis, Minnesota, USA adjoins a major road and bridge where deicing salts are used (**Figure A**). Frank O. Gehry, the building's architect, recognized the corrosive nature of the environment and selected Type 316 (UNS S31600, EN 1.4401, SUS 316) stainless steel wall panels (**Figure B**). Type 316 contains 2% molybdenum, which improves pitting and crevice corrosion resistance. This is particularly helpful in preventing salt damage.

Figure A (above) Type 316 stainless steel with a smooth surface finish and a design that encourages rain cleaning was the right choice for the Weisman Art Museum. Although it is beside a busy road where deicing salt is used, there is no corrosion. The color of the building changes constantly as it reflects the surrounding environment.

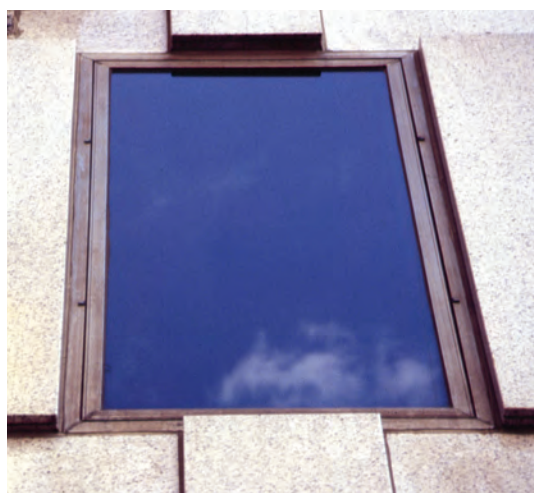
Figure C This Type 304 stainless steel window frame has not been cleaned in five years. Type 304 that is exposed to deicing salt must be cleaned regularly to remove corrosive deposits. Even with that precaution, some staining may occur between cleanings. (Photo Courtesy of the Nickel Institute)

The Type 304 (UNS S30400, EN 1.4301, SUS 304) stainless steel window frame is a few blocks away from the museum on the same busy road (**Figure C**). Both the window frame and the Weisman panel shown in Figure B have similar deicing salt exposure, are about the same distance from the road, and have smooth finishes.

When these photos were taken, it had been about five years since either the window frame or the panel was washed. The only significant differences between them are the type of stainless steel used and that the window frame is partially sheltered from rain by the surrounding closely spaced high-rise buildings.

Although the environment is identical, the appearance of these components is very different. The museum's Type 316 wall panels are in excellent condition with no corrosion and only a small amount of dirt accumulation. The Type 304 window frame is badly stained by corrosion.

Both structures have finishes with surface roughness below $R_a 0.5 \mu\text{m}$ or $20 \mu\text{in}$. Smooth finishes retain less salt, which reduces the possibility of corrosion (score -1). The museum panels are boldly exposed and rain can remove salt deposits. The window frames are slightly recessed and the surrounding buildings shelter them, preventing effective rain washing (score +1). Unless sheltered areas are manually washed or a more corrosion resistant stainless steel is used, these frames are more likely to have corrosion problems.

Even with a smooth finish, Type 304 should not be specified in areas where deicing salts are used unless it will be cleaned frequently. In similar applications, adequate performance has been achieved by cleaning four times per year but there may be light staining between cleanings. This frequency of cleaning would lower the window score to 2 making Type 304 an acceptable choice. In applications with moderate deicing salt exposure, Type 316 stainless steel typically provides good performance if a smooth surface finish and vertical finish grain orientation are specified, surfaces are boldly exposed to rain, and there is heavy rain on a sufficiently frequent basis to remove surface deposits.
