## Case Study 05 Hong Kong Building Exteriors and Railings

High Urban Pollution

High to Moderate Coastal Salt Exposure

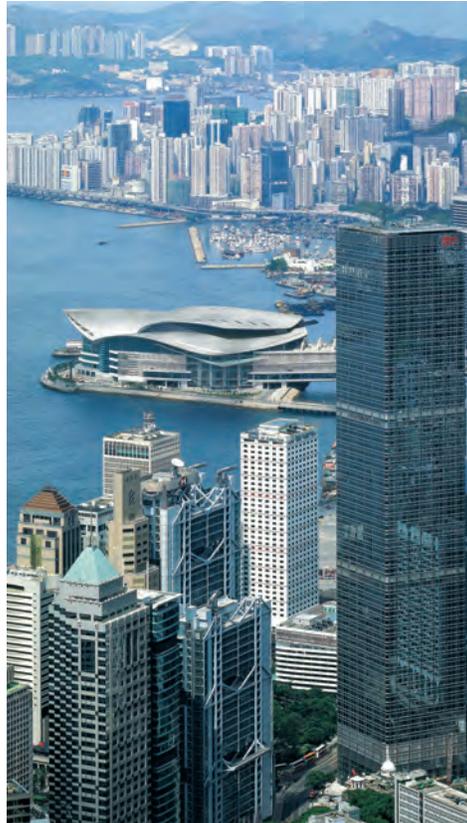
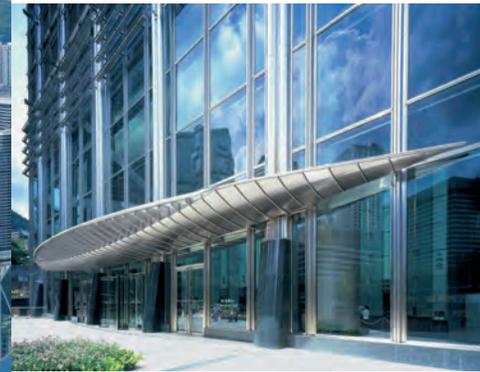
**Figure A and B** Cheung Kong Center is the high-rise building in the foreground of Figure A. The entrance and other details are visible in Figure B. Type 316 stainless steel with smooth surface finishes was an excellent choice because it is exposed to pollution and coastal salt. Window washing tracks were built into the building for easy cleaning. As shown in Figure A, it is in close proximity to the harbor. (Photos Courtesy of Outokumpu)

Hong Kong's 63-story, Cheung Kong Center was completed in 1999. The exterior is glass and Type 316 (UNS S31600, EN 1.4401, SUS 316) stainless steel. Type 316 stainless steel contains 2% molybdenum, which improves resistance to corrosion caused by pollution and salt. **(Figures A and B)** The building is less than 1.6 km (1 mile) but more than 30 m (100 ft) from the harbor. It is exposed to sea salt in the air and rain but not salt spray. Both a coined HyClad Cambric and a fine No. 4 finish were used on the exterior. Rain and regular maintenance cleaning remove the corrosive contaminants and dirt from these smooth finishes. Cheung Kong Center was designed collaboratively by the architecture firms Cesar Pelli, Leo A. Daly, and Hsin-Yieh and has retained its original attractive appearance.

The railing's surface roughness is above  $R_a$  1 µm (40 µin), which increases the score (+2). Rougher finishes retain corrosive substances longer allowing corrosion to occur and provide time for evaporative concentration of salt water. Cheung Kong Center has smooth finishes. The HyClad Cambric pattern was pressed onto base metal with a surface roughness of about  $R_a$  0.1µm (4 µin). The base metal's surface roughness should be used in determining the score as long as the pattern is easily cleaned and is unlikely to retain contaminants (score = -2). The polished tubing's surface roughness was below  $R_a$  0.5 µm (20 µin) (score = -1).

Cheung Kong Center Score = -2

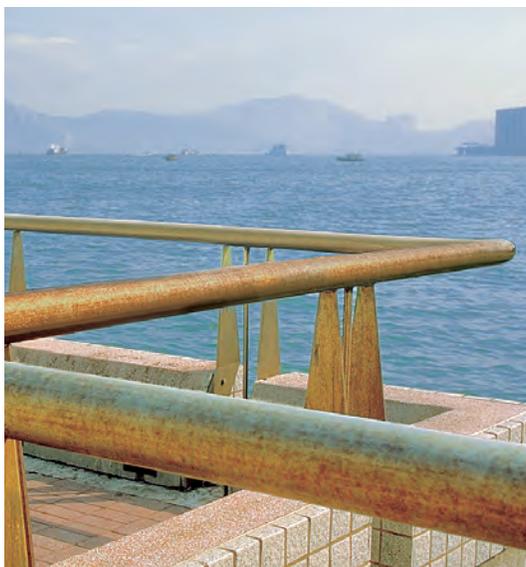
**Figure C** Seawater splashing or spray will corrode Type 316 stainless steel. The rough surface finish on these railings and infrequent washing made the problem worse. (Photo Courtesy of the Nickel Institute)

The very rough finish on the railing retains salt and corrosive pollution products, and these accelerate corrosion. **Figure C** shows the level of staining after three years without cleaning. The top rail is now cleaned daily and the lower sections are cleaned monthly to minimize corrosion staining. Specification of a more corrosion resistant stainless steel and a smooth finish would have minimized or eliminated the need for cleaning.

Coastal salt (chlorides) can corrode architectural metals, including some stainless steels. The most corrosive coastal applications are exposed to salt-water spray, splashing, and/or immersion. Boat traffic, wind levels, and other factors can generate marine salt aerosols and spray. The railing is exposed to some sea spray and occasional splashing (+5). Cheung Kong Center is only exposed to sea salt in the air and rain (+3).

The convention center railing was not cleaned during the first three years of service (Figure C), and remedial cleaning was required to restore the finish. The top rail is now cleaned daily and the rest is cleaned monthly. The sections that are cleaned monthly show light staining between cleanings. The stainless steel on Cheung Kong Center is cleaned when the windows are cleaned, which is typically four or more times per year. If the air borne particulate level continues to decrease, less frequent cleaning would be needed to maintain Cheung Kong Center's attractive appearance.
