A Workable, Lasting Solution for Water Losses through Leaking Water Pipes

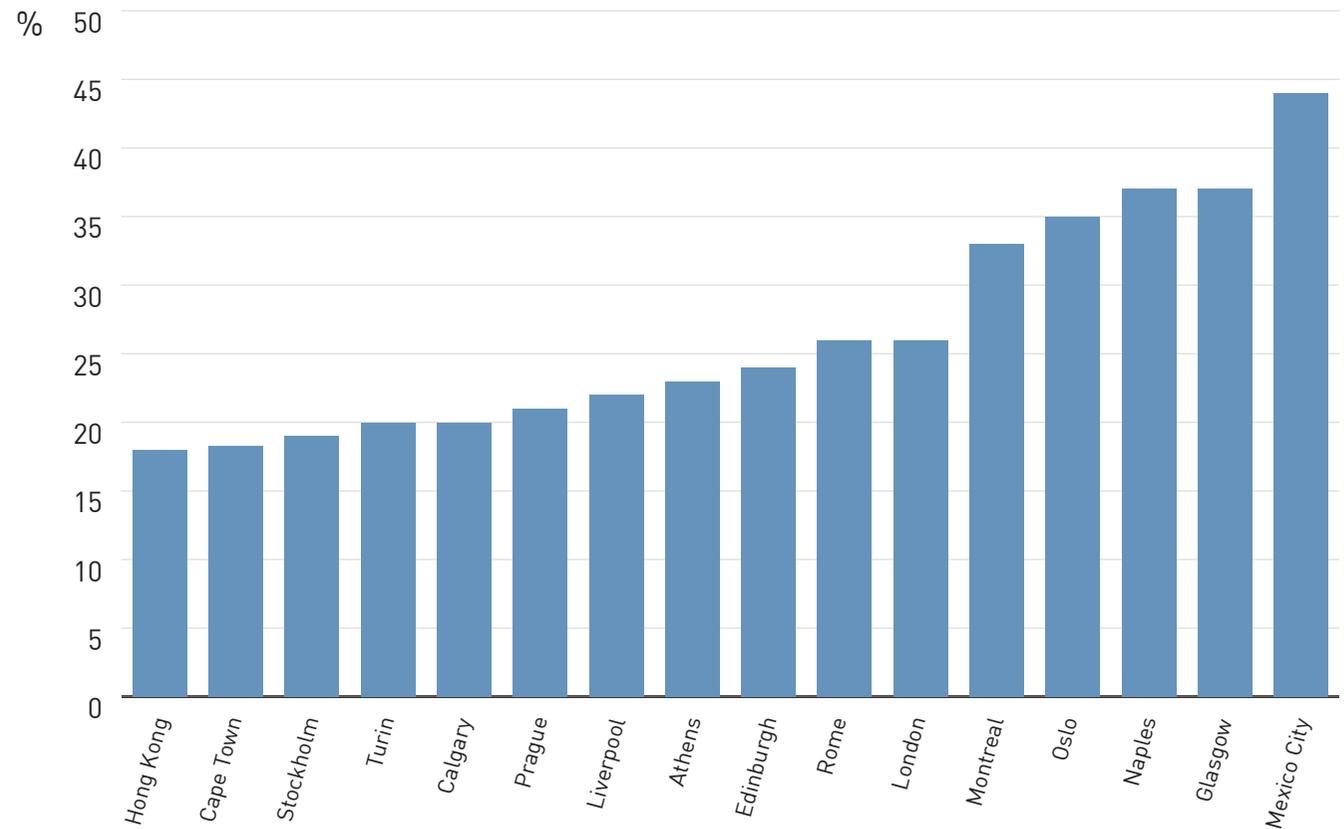
Leakage rate in major cities
Source: OECD (Water Governance in Cities, 2014)

Water loss through leaking water pipes is a problem for cities all over the world. Some of them are losing water at upwards 40% per year, and this is all water which has already been treated. A recent study by the OECD has shown that it is not only the under developed or even the developing cities that are so affected – even the capital cities of major economies are losing far more water than is sustainable or even viable, as the table on this page illustrates.

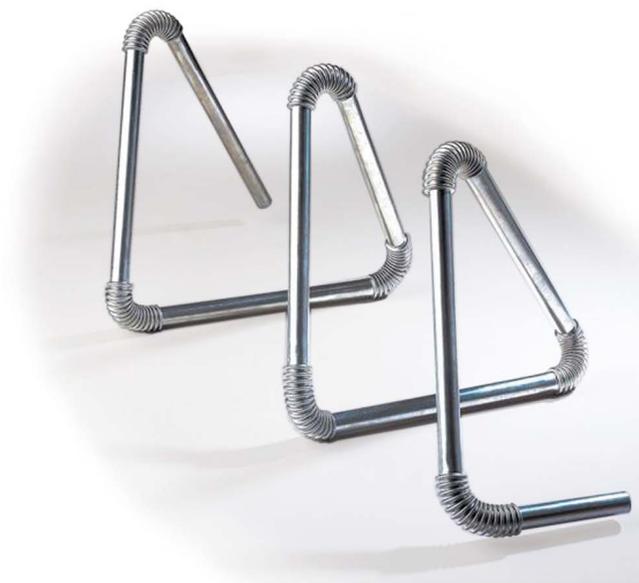
*Corrugated stainless steel pipes.
Source: Korea Water Works Association (kwwa.or.kr)*

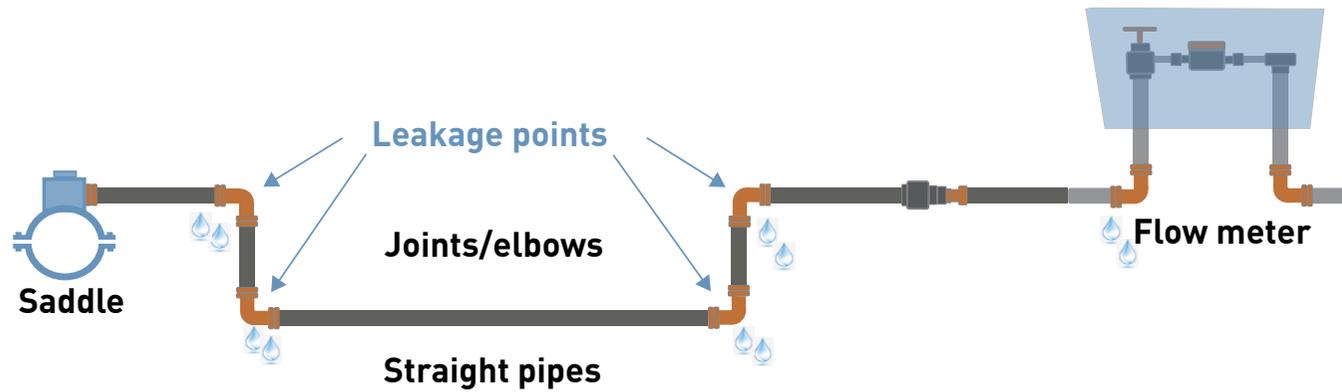
Traditional Piping System

A flexible stainless steel corrugated piping system:

- avoids leaking at joints
- reduces the number of joints
- resists seismic shocks

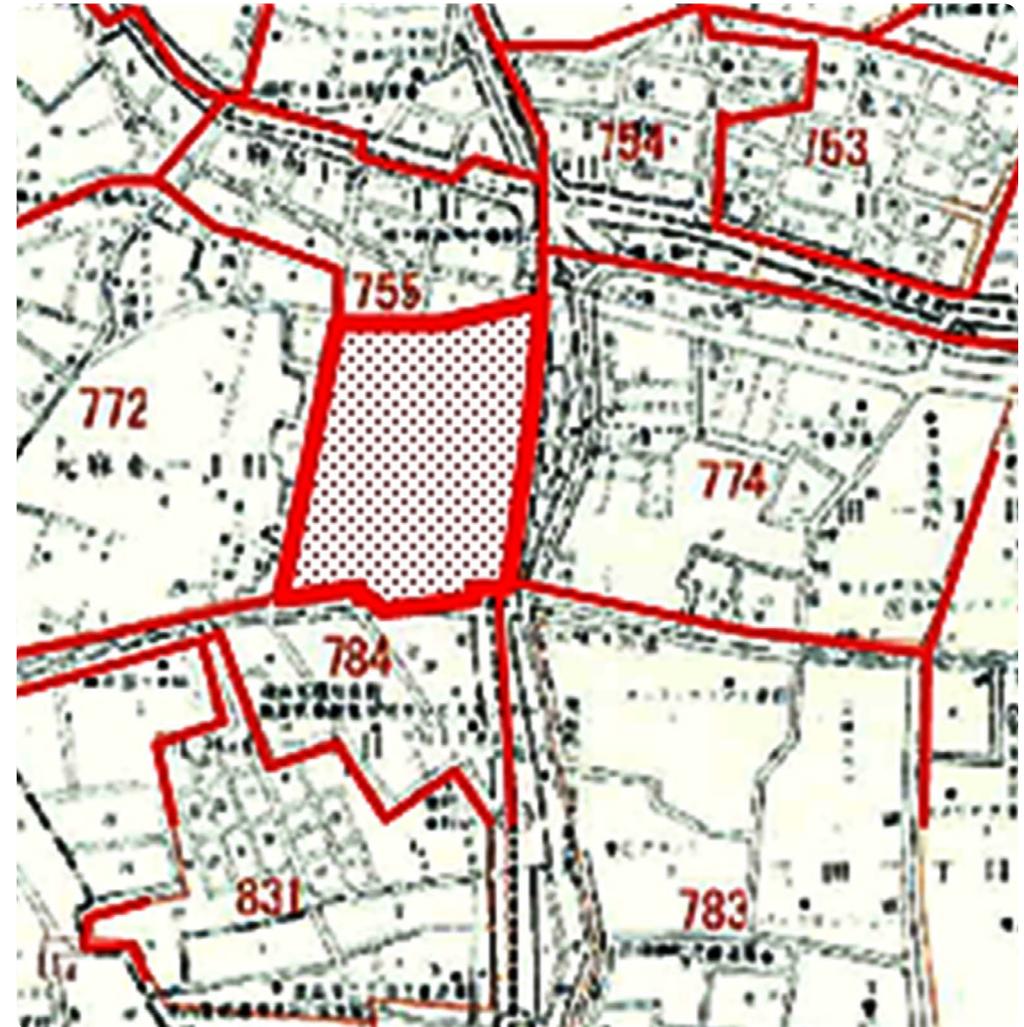
Example of how Tokyo is divided into grid blocks to plan the regular detection of leaks

- Each service area is divided into grid blocks
- Each block is investigated systematically for leaks

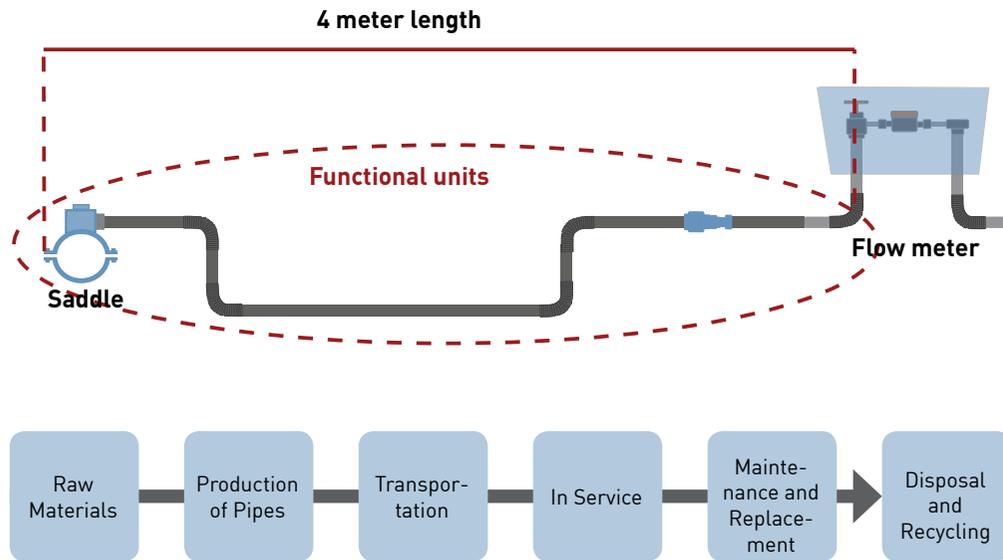
4 meter lengths (20 mm diameter) of service pipes with a service life of 100 years. Service pipes extend from the water mains to the household water meter and are inclusive of joints, elbow, T-joints and valves.

The LCC analysis was calculated from cradle to grave.

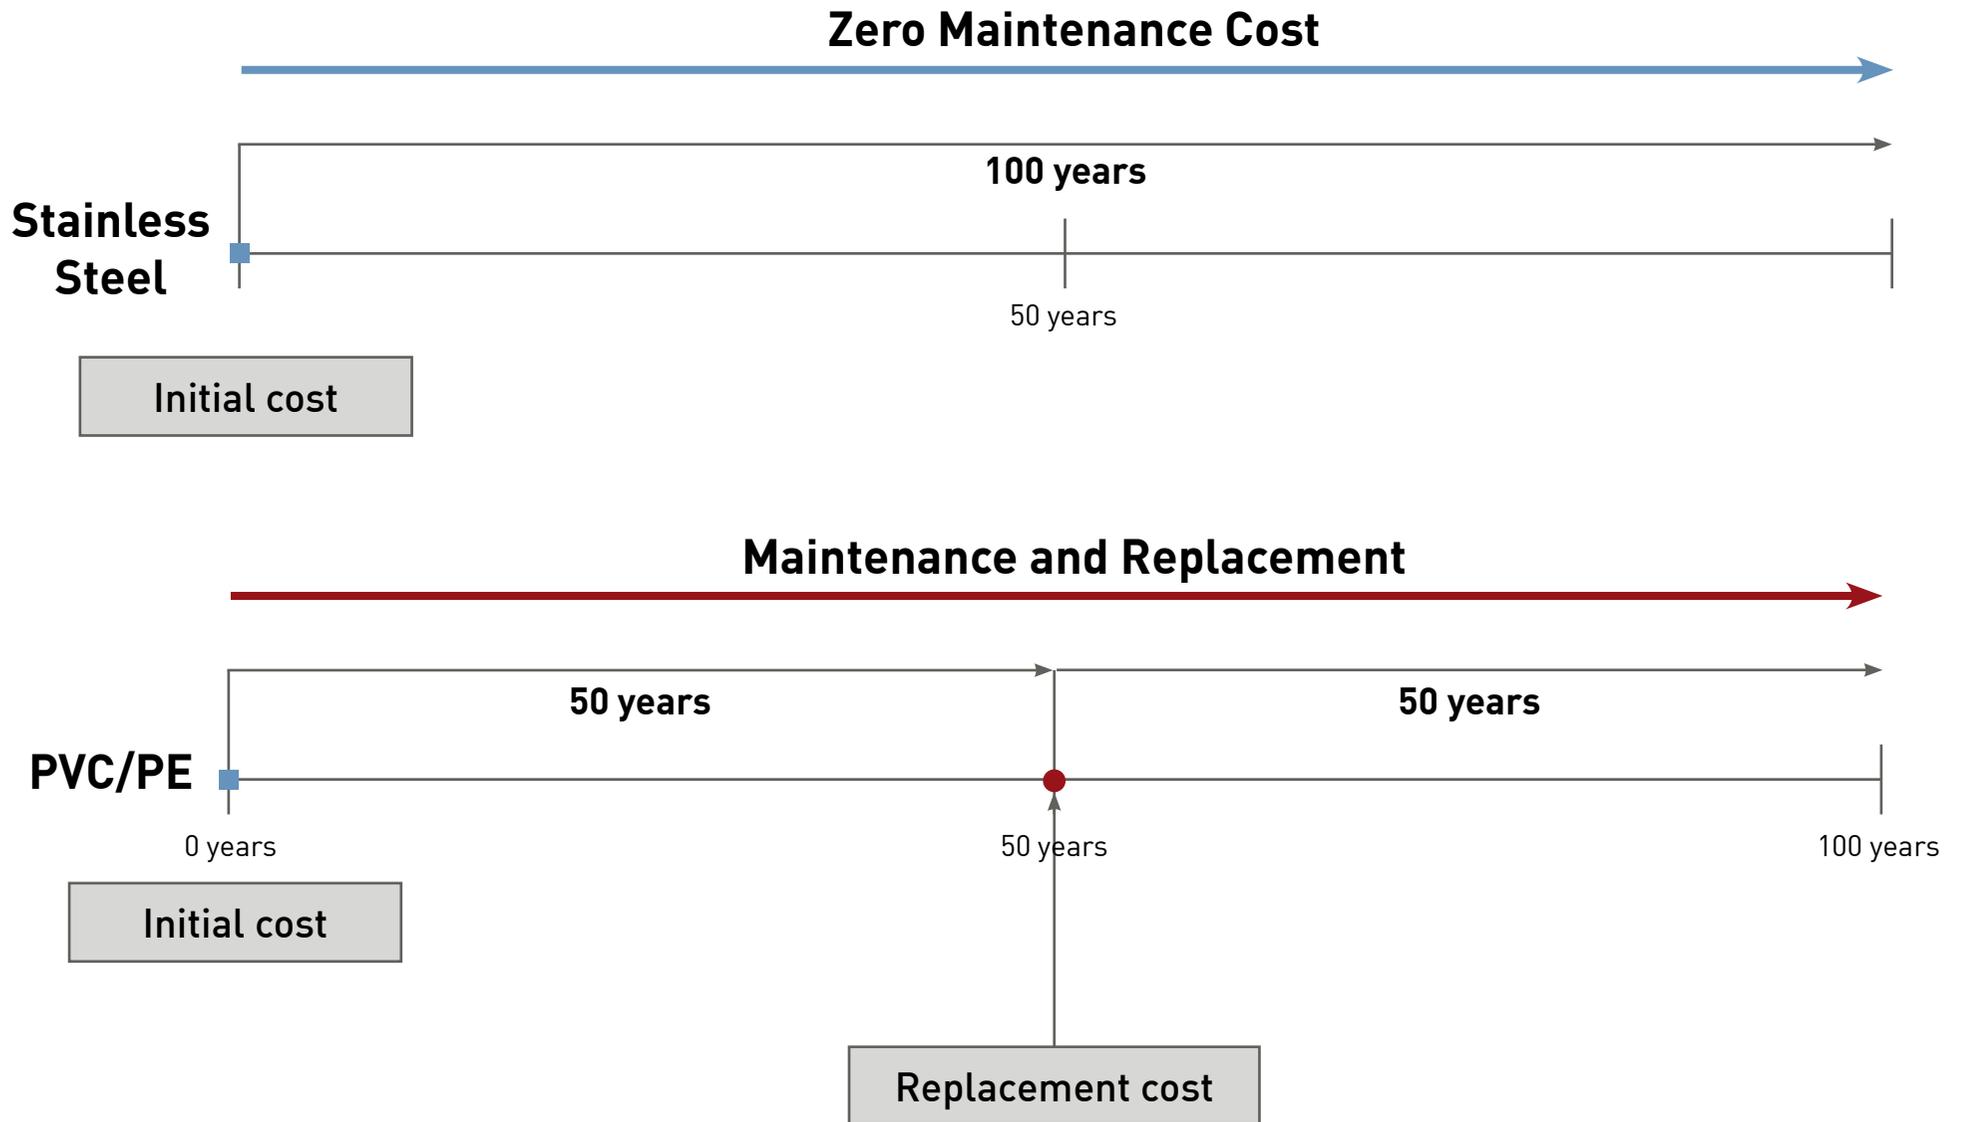
Cost diagram for each material

Duration	Stainless Steel	PVC	PE
100 years	\$1,932	\$3,321	\$3,279

The analysis of the Life Cycle Cost for grade 316 stainless steel illustrates that it is a less expensive product when viewed over its useful life.

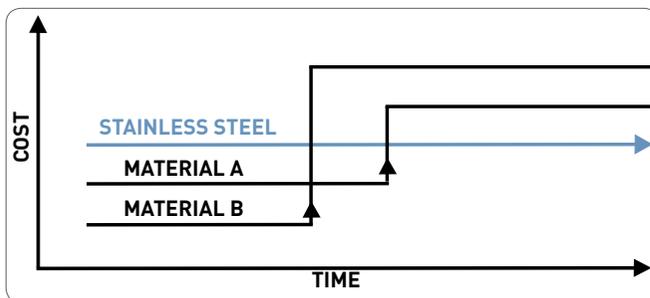
Schematic representation showing the cost of alternate materials A and B substantially increases over time while the cost of stainless steel remains constant.

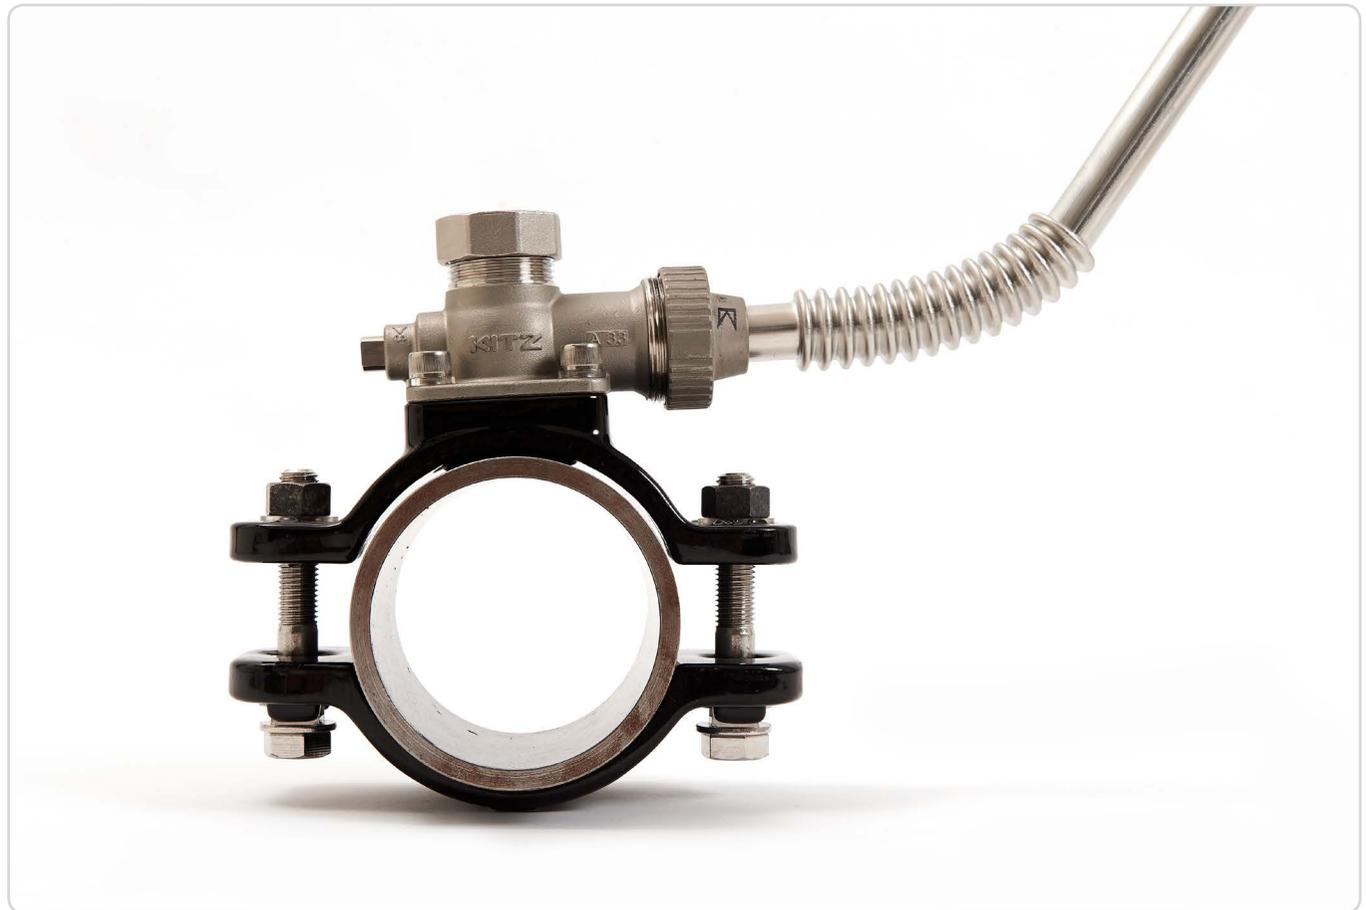
*Saddle used with the stainless steel corrugated pipe system
Photographer: Philippe De Putter*

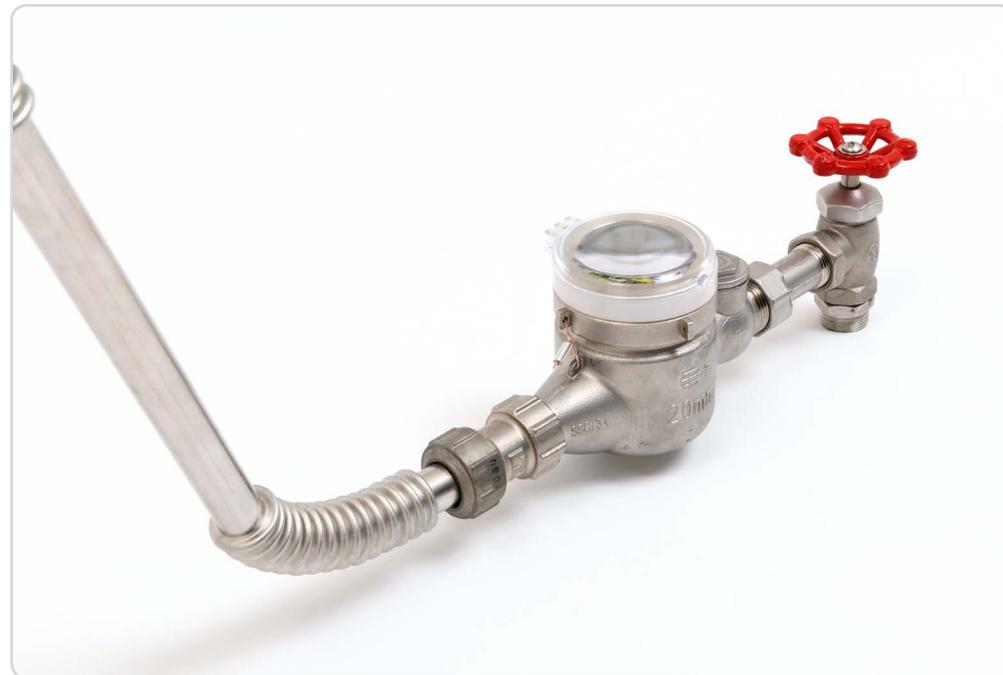
*Flow meter and stopcock with the stainless steel corrugated pipe system
Photographer: Philippe De Putter*

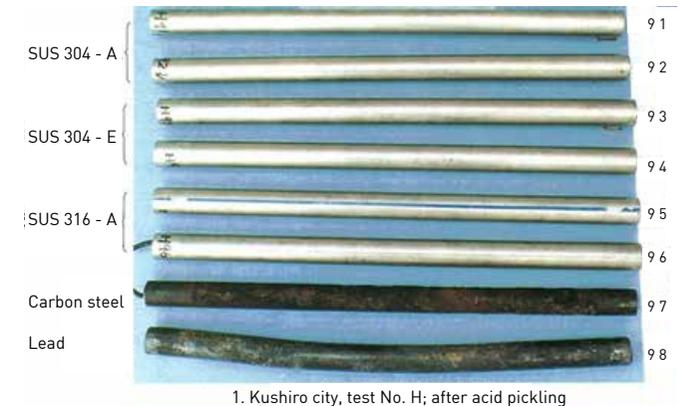
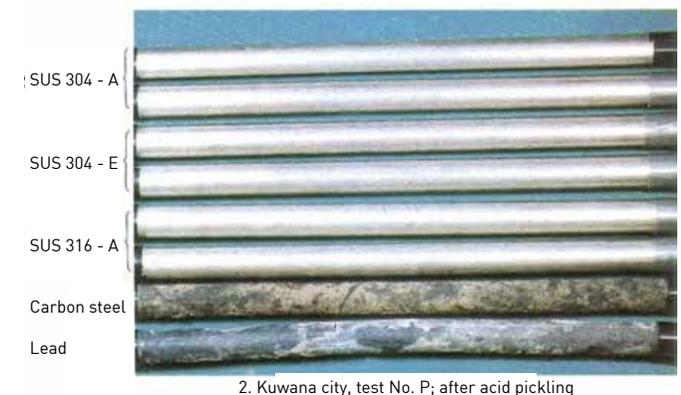
Photos of the burial test results after 10 years of burial in Kushiro (North-East Japan) and Kuwana (Central Japan).

To check the corrosion behaviour of the pipes and to collect data on their corrosion resistance, the Tokyo Water Board commissioned tests using pipes made from a number of competing products, by burying them underground at 10 different sites, for a period of 10 years.

The tests showed that stainless steel had performed better in terms of strength and corrosion resistance with grade 316 performing better than 304. The Cl⁻ and SO₄²⁻ concentrations in the soil were very high. The tests showed no evidence of pitting corrosion on the 316 samples. 316 is a higher alloyed grade and therefore more expensive than 304, but the Tokyo Water Board decided that the greater cost is the cost of laying the pipes and that the risk of failure could not be tolerated because of a potential water shortage. As a result, the decision to specify the stronger of the two grades of stainless steel irrespective of the initial costs difference, was economically justifiable.

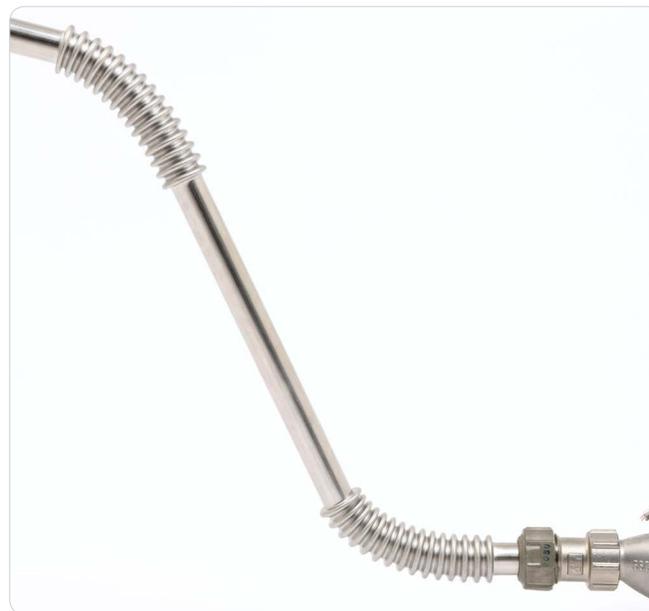
Stainless Steel Corrugated Pipe
 Photographer: Philippe De Putter

The Tokyo Water Board discovered that many of their leaks had occurred at joints. The use of corrugated pipes allowed the installers to bend the pipes to the required shapes, thus reducing the need for joints and elbows, but it also allowed the pipes to remain more flexible after installation, and therefore more capable of resisting seismic shocks.

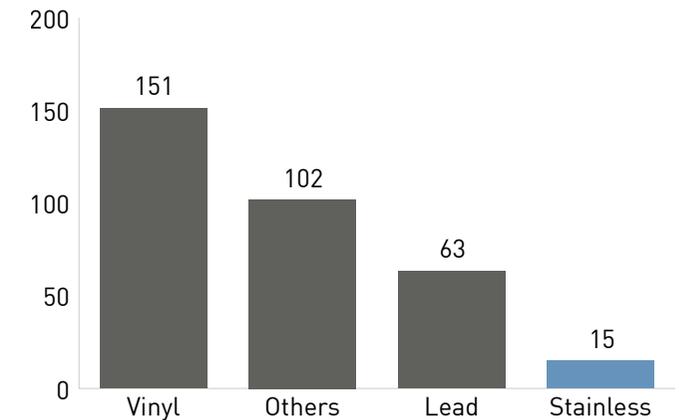
Number of damages after the Great Earthquake of 2011 per pipe material.

City lies on the boundary between the areas demarcated as having a strong to very strong impact (the earthquake was felt as far away as Beijing). After this incident inspections revealed that only 5% of the stainless steel pipes which had been installed were damaged.

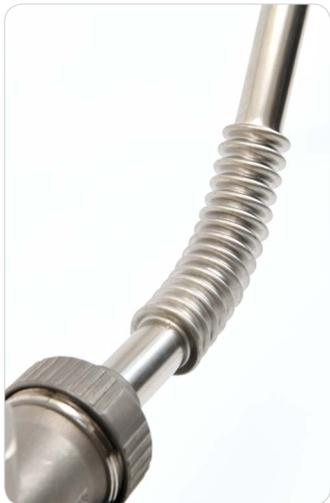
Stainless Steel Corrugated Pipe
Photographer: Philippe De Putter

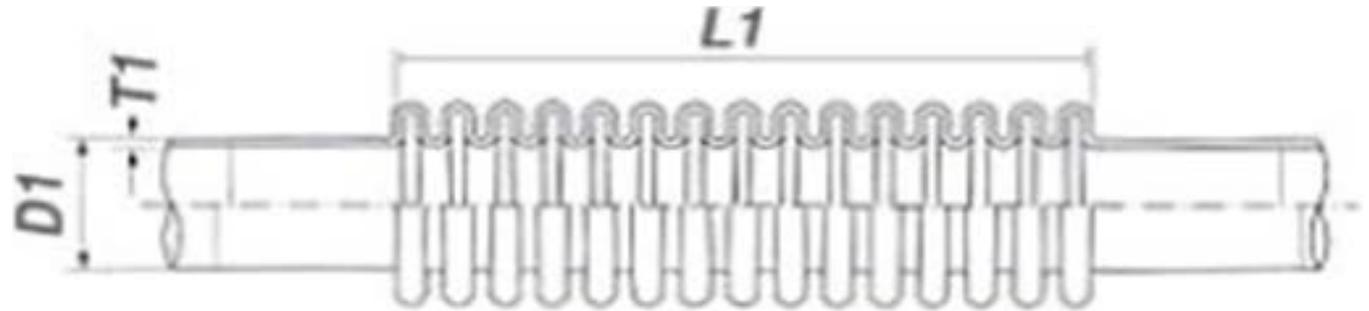
Drawing of a corrugated pipe. D1 is the diameter, T1 the thickness and L1 the length of the corrugation. Specifications for the different diameter pipes can be found in the table.

Name	Outer diameter (D1)		Thickness (T1)		Length (L1)		# of thread	
	Standard	Tolerance	Standard	Tolerance	Standard	Tolerance		
13Su	15.88	0~0.37	0.8	±0.08	80	±10	15	
20Su	22.22		1	±0.1	120			
25Su	28.58							
30Su	34	±0.34	1.2	±0.12	153	±20	20	
40Su	42.7	±0.43			225			
50Su	48.6	±0.49

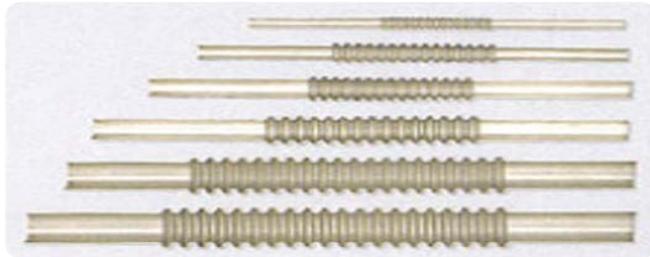
Corrugated stainless steel pipes in different diameters

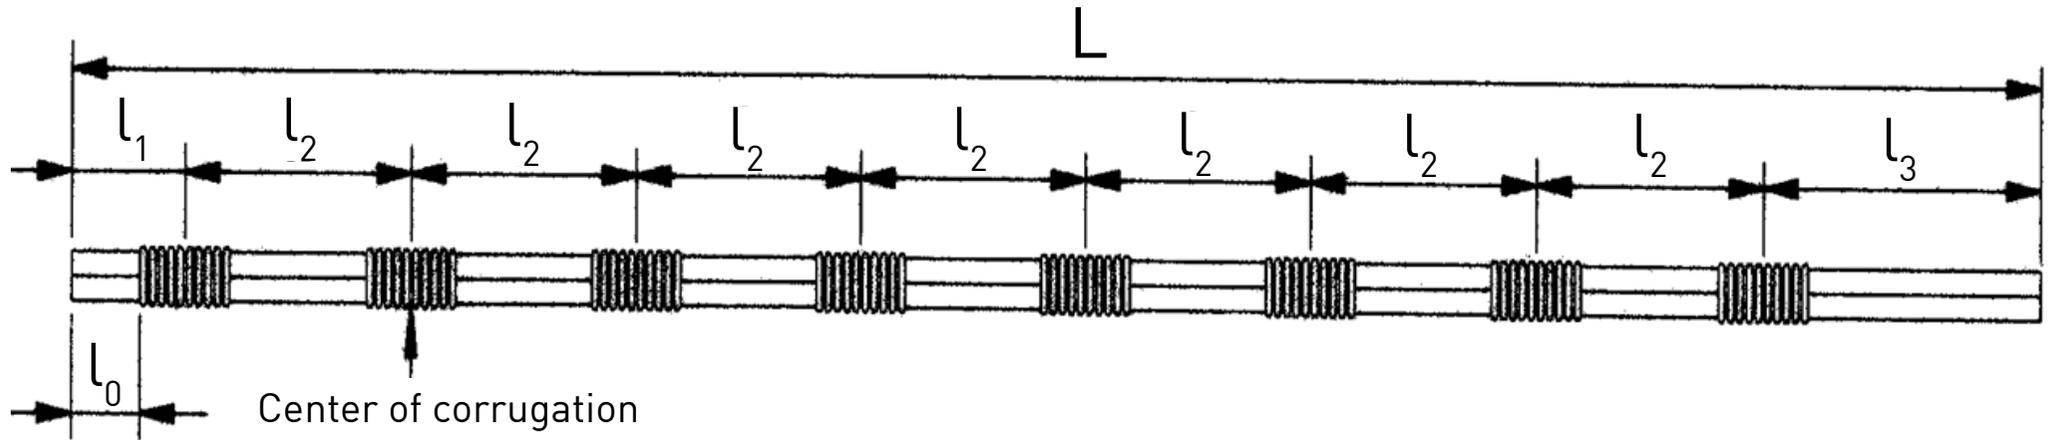
Name	L		l_1		l_2		l_3		l_0
	Standard	Tolerance	Standard	Tolerance	Standard	Tolerance	Standard	Tolerance	Standard
13 Su	4,000	± 0	190	+10 -0	475	± 20	485	± 0	150
20 Su			210		475		465		150
25 Su			210		475		465		150
30 Su			230		470		480		153.5
40 Su			265		460		515		152.5
50 Su			265		460		515		152.5

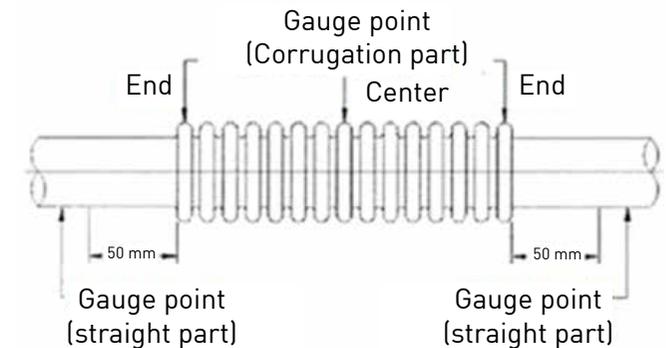
- E. Hardness: equal or lower than HV200 on the corrugation section
- F. Shock resistance: no leakage or malfunction after 2 kg steel ball drop test from 1 meter high
- G. Thickness reduction ratio (r): equal or less than 20%
 $r = (1 - t_1/t_2) \times 100$, where
 r is the reduction ratio
 t_1 is the lowest thickness of corrugation
 t_2 is the lowest thickness of straight pipe
- H. Bio-elution: must confirm with the national regulations

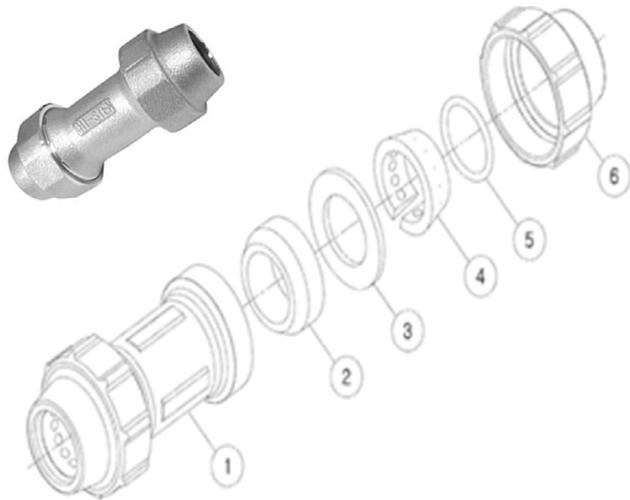
Specification (Joint) - made of cast stainless steel

Item	Description	Material
1	Body	SSC13/14
2	Packing	EPDM
3	Washer	STS304/316
4	Ball Guide	STS304/NYLON6
5	O-Ring	EPDM
6	Nut	SSC13/14

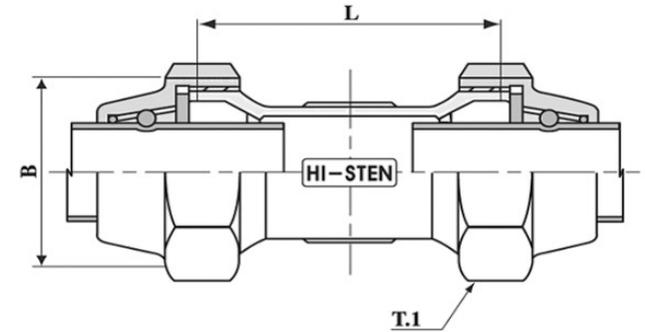
*EPDM: Ethylene Propylene Diene Monomer (It will last more than 100 years at room temperature water and more than 40 years at 70~80 degree in Celsius)

(mm)	L	B	T.1
13Su	80	41.0	Hexagonal
20Su	80	47.0	Hexagonal
25Su	80	55.5	Hexagonal
30 Su	90	61.5	Octagonal
40Su	90	71.0	Octagonal
50Su	90	78.0	Octagonal
60Su	90	90	Octagonal

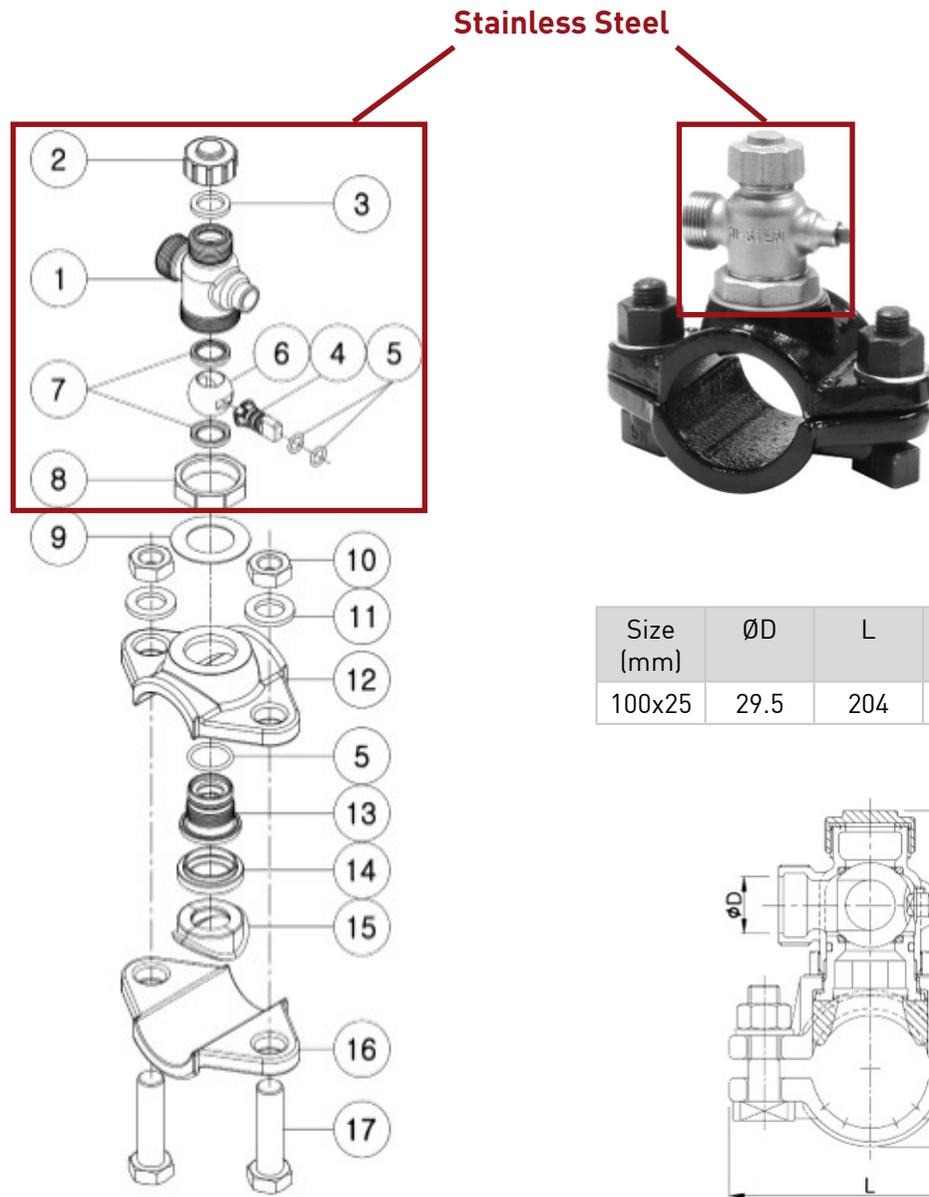
**Specification (Snap Tap with Saddle)
- made of cast stainless steel and
carbon steel (ductile)**

Item	Description	Material
1	Body	SSC13/14
2	Cap	SSC13/14
3	Cap Packing	EPDM
4	Stem	STS304/316
5	O-ring	EPDM
6	Ball	STS304/316
7	Seat	PTFE
8	Lock Nut	SSC13/14
9	Insulation Pad	PE
10	Nut	FCD450
11	Washer	SS400
12	Saddle	FCD450
13	Insert	SSC13/14
14	Insulation Guide	PE/EPDM
15	Upper Packing	EPDM
16	Band	FCD450
17	Bolt	FCD450
