# Moly rescues a lady in distress

Since its dedication in New York harbor on October 28, 1886, The Statue of Liberty has become one of the world's best-known sculptures. However, after nearly 100 years in the aggressive marine environment, galvanic corrosion between the iron framework and the copper skin caused major structural deterioration. Molybdenum-containing stainless steel played a crucial role in restoring this iconic landmark.

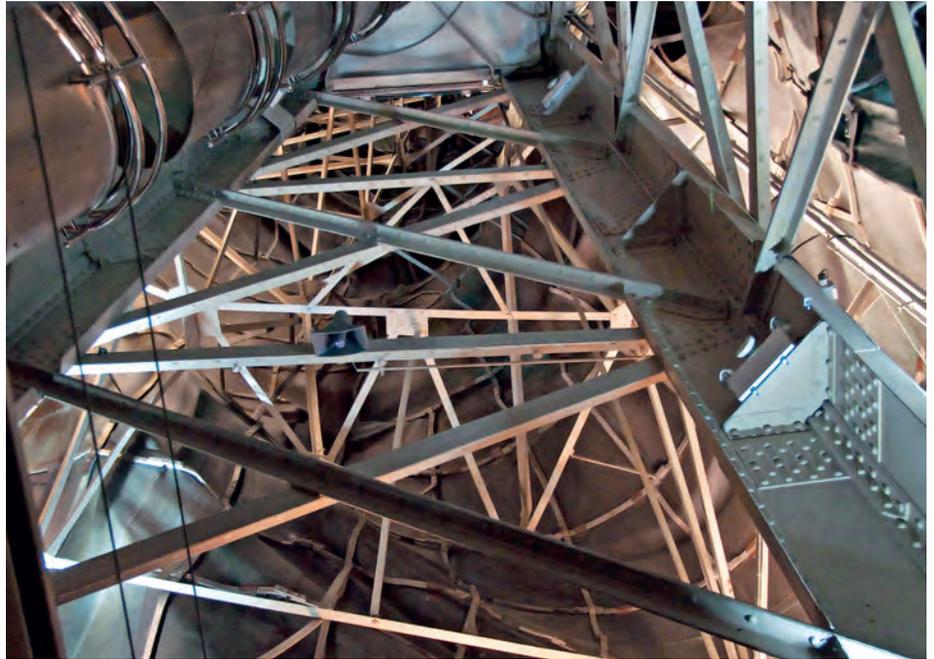
Looking up through the central pylon the intricate detail of the unique structure built to support the statue's façade can be seen. © Mike Renlund

The original structure of the 46-meter statue had a puddled-iron framework of a central pylon, secondary framing and armature bars. The central support

pylon had four cross-braced legs with a double-helix staircase rising through its center. The secondary iron framework connected the 1850 puddled-iron armature bars to the pylon. The armature bars supported the copper sheets and allowed movement. About 1,500 U-shaped copper saddles connected the armature to the 73-tonne, 2.4-mm thick copper envelope. This inspired structural design allowed the envelope to flex and expand, and avoid cracking due to heat, cold, and wind.

There had also been significant deterioration of the secondary framework. The restoration team replaced much of it with a new high-strength secondary framework of highly corrosion resistant, molybdenum-containing duplex stainless steel (UNS S32550). The new framework is attached to the central pylon and supports the Type 316L armature. The sections of the original secondary framework that remained were cleaned and coated with a zinc primer and epoxy topcoat. These layers protect it from
