## Case Study 13 Rio de Janeiro Building Exterior

Moderate Industrial Pollution Exposure  
Low Coastal Salt Exposure

VIVO's new headquarters in Rio de Janeiro was completed in 2005. The three-story building (42,397 m<sup>2</sup> or 456,357 ft<sup>2</sup>) was designed by the Brazilian architecture firm Edo Rocha.

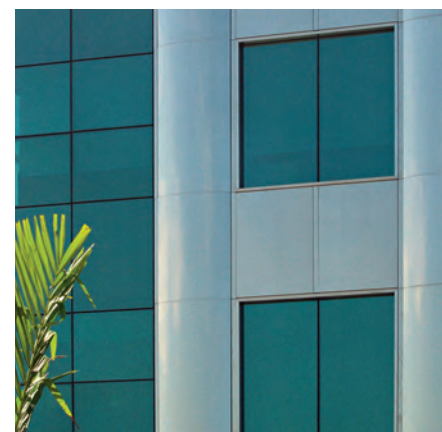
**Figure B** Close-up of the building exterior.  
Photo Courtesy of Núcleo Inox

Two different stainless steel finishes were used for the façade. The curved panels have a No.7 finish making them quite reflective. The flat panels have a No. 4 finish. The surface finishes have a maximum surface roughness of  $R_a$  0.4  $\mu$ m (16  $\mu$ in).

The surface roughness of the finishes is less than  $R_a$  0.5  $\mu\text{m}$  (20  $\mu\text{in}$ ). Smooth finishes retain fewer corrosive substances and dirt. As long as the surfaces are boldly exposed, this also makes natural rain-washing more effective. The specification of smooth finishes reduces cleaning requirements and helps to keep the building sparkling clean.

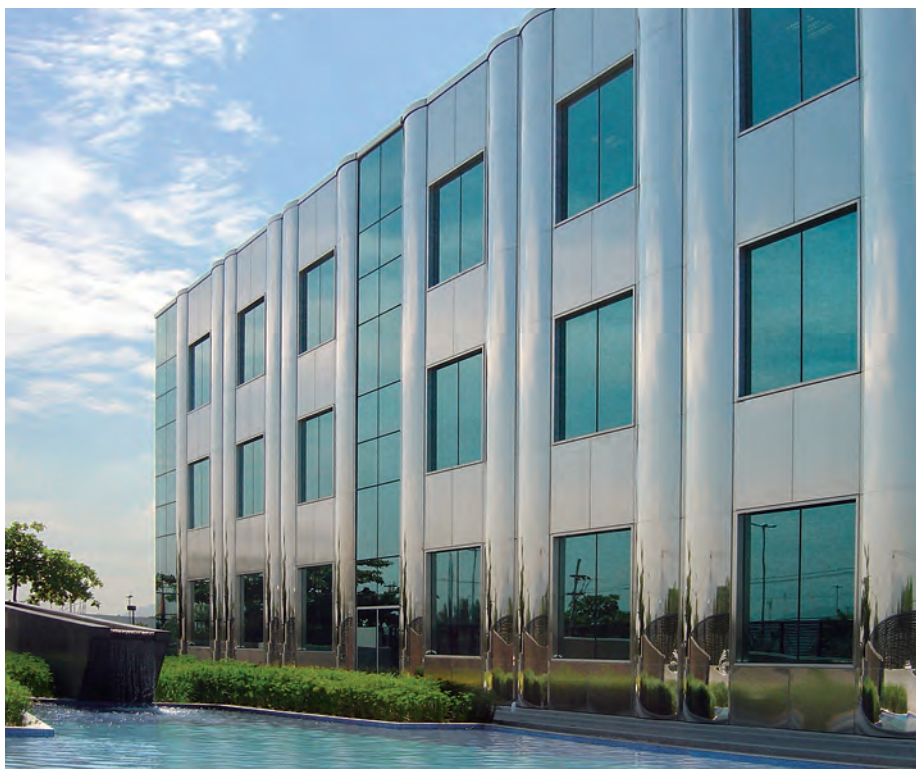
**Figure A** A view of the exterior of the new VIVO building in Rio de Janeiro. Photo courtesy of Núcleo Inox
