# **Case Study 10 New York Pier Railings**

## Low Pollution Exposure High Coastal Salt Exposure

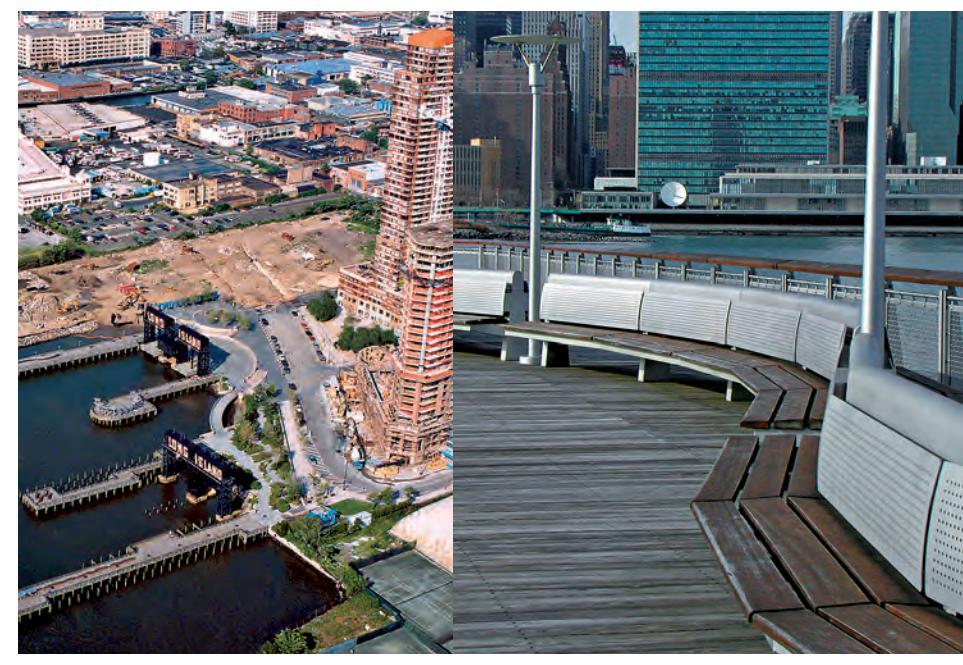
Figures A and B The Gantry Plaza State Park piers jut into the East River and make extensive use of Type 316 stainless steel seating and railings. The United Nations building is visible across the river. (Figure A: Photo Courtesy of Abel Bainnson Butz, LLP)

New York City is spread over several islands. Long Island's new Queens West mixed-use development takes advantage of exceptional views of Manhattan Island. Gantry Plaza State Park is being developed on the East River waterfront in front of Queens West. Four rehabilitated industrial piers are part of the section of this park that was completed in 1998. (Figure A) The East River, which separates the islands, is a heavily traveled, narrow, brackish tidal strait.

Type 316 stainless steel (UNS S31600, EN 1.4401, SUS 316) is generally the most cost-effective choice for low maintenance, boldly exposed, long-term applications near the coast. It contains 2% molybdenum, which helps to prevent corrosion caused by salt. For maximum corrosion resistance, a smooth, micro-crevice free surface finish is needed. In this case, the railings and seating are Type 316 stainless steel with a rougher glass bead blasted finish. Despite this finish, most of the Type 316 stainless steel has remained attractive and corrosion free. **(Figure B)**

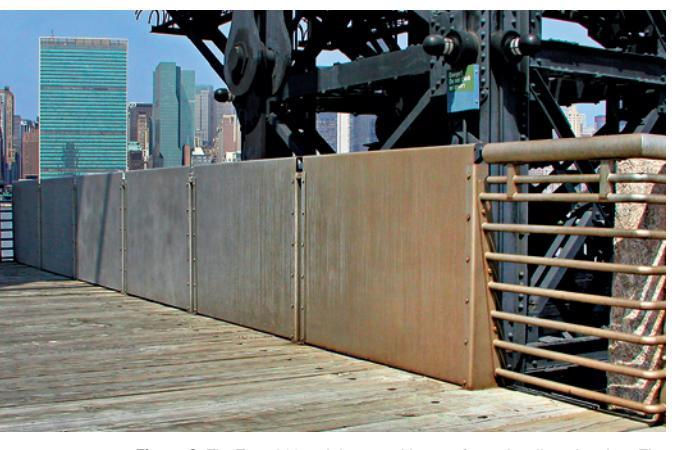
Figure C The Type 316 stainless steel has performed well on the piers. The exception is the splash zone, where there is discoloration caused by corrosion staining (right side of image).

Direct exposure to salt water spray or splashing is much more corrosive than typical coastal exposure. During high tide, brackish water hits the rocks and the old loading towers (gantries) concrete supports. Water splashes onto the stainless steel railings along the shore causing localized corrosion of the Type 316 stainless steel railings. **(Figure C)** Although it is unattractive, the corrosion rate is low and structural failure is not a concern. This staining is easily removed by cleaning.

After the Type 316 stainless steel corrosion problem was observed in the splash zone, a fifteen-month study was conducted using nine different stainless steel and finish combinations. All of the samples had rough finishes and were placed in the splash zone. Duplex 2205 stainless steel (UNS32205, EN 1.4462, SUS 329J3L) with a dull pickled finish provided the best performance. In localized splash zones, upgrading to a more corrosion resistant stainless steel can prevent staining. Higher strength duplex stainless steels can be used to reduce section sizes and material cost. A report on this corrosion study is available at http://www.imoa.info.
