# Case Study 08 São Paulo Building Exterior

### High Urban and Industrial Pollution No Salt Exposure

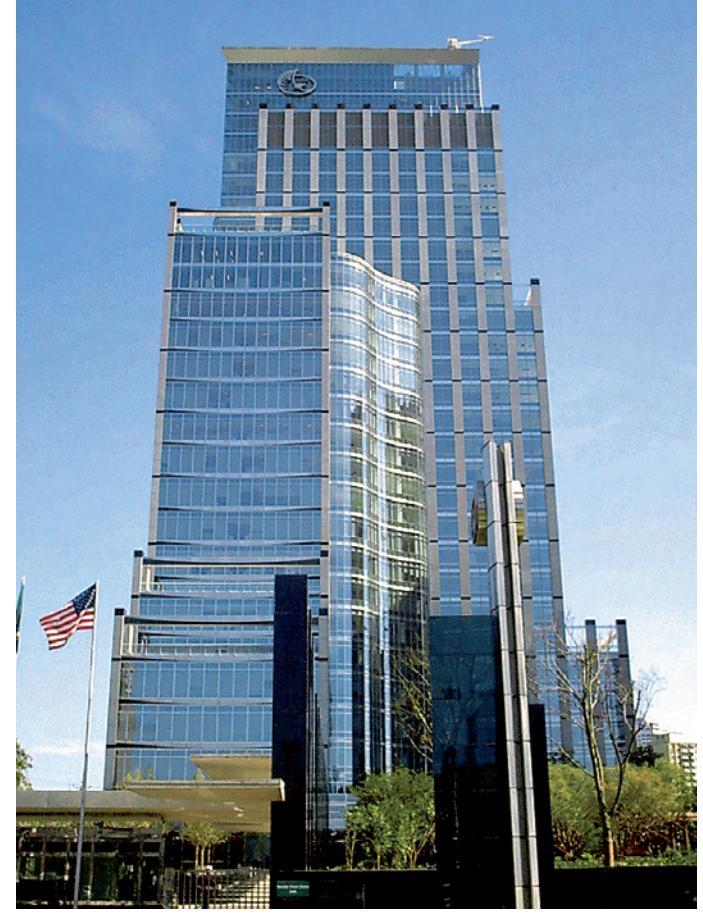
Figure A Careful stainless steel selection, design and maintenance ensure that the exterior will remain beautiful over time. (Photo Courtesy of Núcleo Inox)

Bank Boston's new South American headquarters in São Paulo, Brazil was completed in 2002. The 30-story building was designed by the international architecture firm Skidmore Owings & Merrill, LLP in conjunction with the Brazilian architecture firm Escritório Técnico Júlio Neves. (Figures A and B) It was designed using "green" building concepts, making material service life an important consideration.

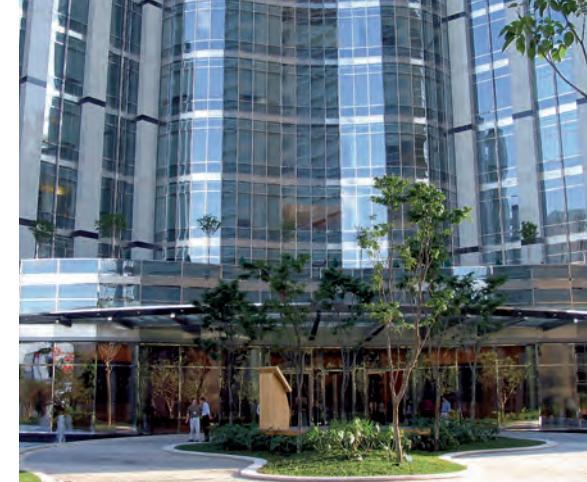
Figure B All three stainless steel finishes can be seen around the building's parklike entrance. (Photo Courtesy of Núcleo Inox)

Three different stainless steel finishes were used on the exterior. Black electrochemically colored stainless accentuates building details. A coined cambric finish was used for spandrel panels and a No. 4 polished finish was used for the entrance canopy, column covers, and other details.
