Case Study 09 Australian Coastal Fence

Low Pollution Exposure High Coastal Salt Exposure

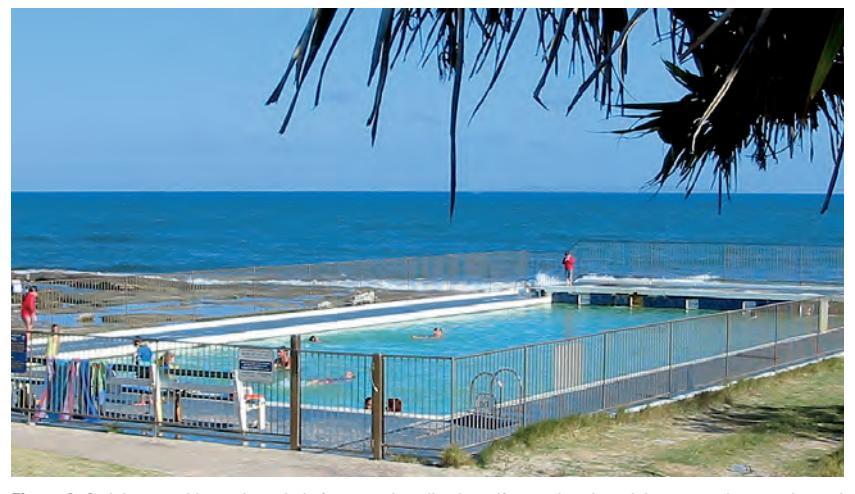
Both Type 304 (UNS S30400, EN 1.4301, SUS 304) stainless steel and Type 316 (UNS S31600, EN 1.4401, SUS 316) stainless steel were used for a fence around a seawater swimming pool adjoining the ocean. (Figure A) The posts are Type 304 stainless steel and the other railing and gate components are Type 316 stainless steel. As can be seen in **Figure B**, the posts are corroding.

Figure A Stainless steel is used regularly for coastal applications. If properly selected, it can remain attractive and structurally sound in this corrosive environment. (Photo Courtesy of Australian Stainless Steel Development Association)

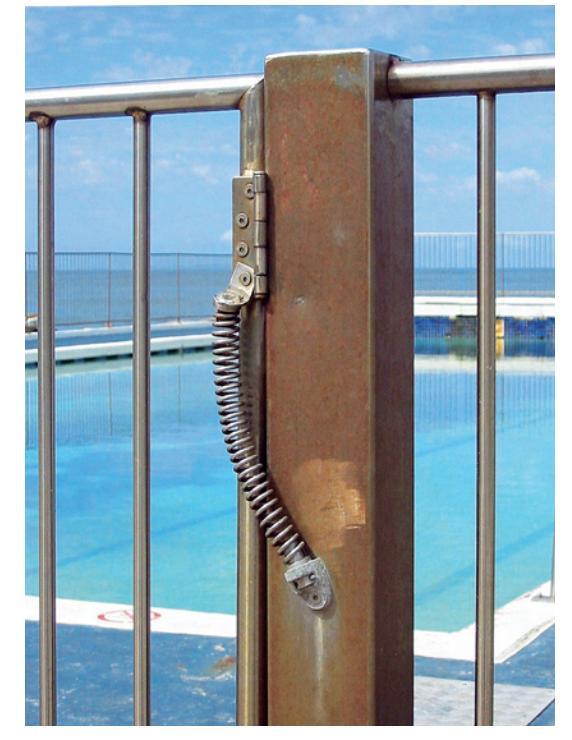
Figure B The contrast in appearance between the gate and support post is due to stainless steel chemistry and surface roughness differences. The corrosion-free gate is Type 316 stainless steel and the post that is discolored by corrosion is Type 304 stainless steel.

Stainless steel is more resistant to corrosive coastal salts (chlorides) than other common architectural materials. Type 316 stainless steel is generally the most cost effective material choice for long-term, low-maintenance applications that are near the coast but not splashed or immersed in seawater. Type 316 stainless steel contains 2% molyb-denum, which helps to prevent pitting and crevice corrosion caused by deposited salts. In low or no maintenance applications like this pool fence, it is also important to specify a smooth surface finish to minimize the potential for corrosion. As can be seen in **Figure B**, there is no corrosion on the Type 316 stainless steel gate and fence components.

When specifying stainless steel in a corrosive environment it is important to seal or eliminate crevices by welding and to use a design that is easily cleaned by rain. Most of the fence components were welded together which is preferred for a long-term structure. Unfortunately, not all of the welds were properly cleaned and dark discoloration (heat tint) and corrosion can be seen around some of the Type 316 stainless steel welds. Heat tint, the surface oxidation associated with the heat of welding, must be completely removed in order to restore the corrosion resistance of the stainless steel. If these welds are ground and/or pickled, they will perform as well as the rest of the Type 316 stainless steel in the fence. Heat tint does not reduce the structural properties, but it may be considered unsightly by the users of the material.

The railing is less than 30 m (100 ft) from the ocean and each section's exposure to salt water varies. The section closest to the ocean is splashed when the surf is "up". (+5) The components shown in Figure B are farther from the water and are only exposed to salt spray during storms but their close proximity to the ocean and the rough surf mean that exposure to coastal salt (chlorides) is high. (+4)

The finishes on the Type 316 stainless steel gate and the Type 304 stainless steel post are very different. The coarse post has an average surface roughness of R_a 1.1 µm (43 µin) which increases the score (+2). The smoother gate has a surface roughness of about R_a 0.46 µm (18 µin), which reduces the score (-1). Corrosive substances have to remain on a surface for corrosion to occur. Rain more easily removes corrosive salt deposits from smooth finishes. In addition, a rougher finish retains rainwater longer, extending the time of wetness when corrosion can occur.

Type 304 stainless steel is not appropriate for coastal applications unless: (1) a very smooth finish is specified; (2) there is regular cleaning; and (3) some staining between cleanings is acceptable. The Type 304 stainless steel fence post corrosion should have been anticipated. The problem was made worse by the very rough finish, which retained corrosive salt (chlorides) and accelerated the corrosion rate. A much more corrosion resistant stainless steel would have been necessary for corrosion-free performance with this rough finish. Although there is corrosion over the entire surface, it is superficial and structural failure is unlikely during the pool life, since it will corrode about 1,000 times more slowly than carbon steel.

A score of 3 means that Type 316 stainless steel is generally the most cost effective choice, so it is not surprising that the gate and most of the Type 316 fence components have remained attractive without maintenance. Type 316 stainless steel performs well in most coastal, low-to-moderate pollution environments as long as smooth surface finishes are specified and regular heavy rains remove surface deposits. Without maintenance, some light staining may occur over time, but it is easily removed. Unless there is regular cleaning, Type 316 stainless steel will corrode if it is regularly sprayed or splashed with salt water. This is why the fence section immediately adjoining the water has a score of 4.
