Case Study 10 New York Pier Railings

Low Pollution Exposure
High Coastal Salt Exposure

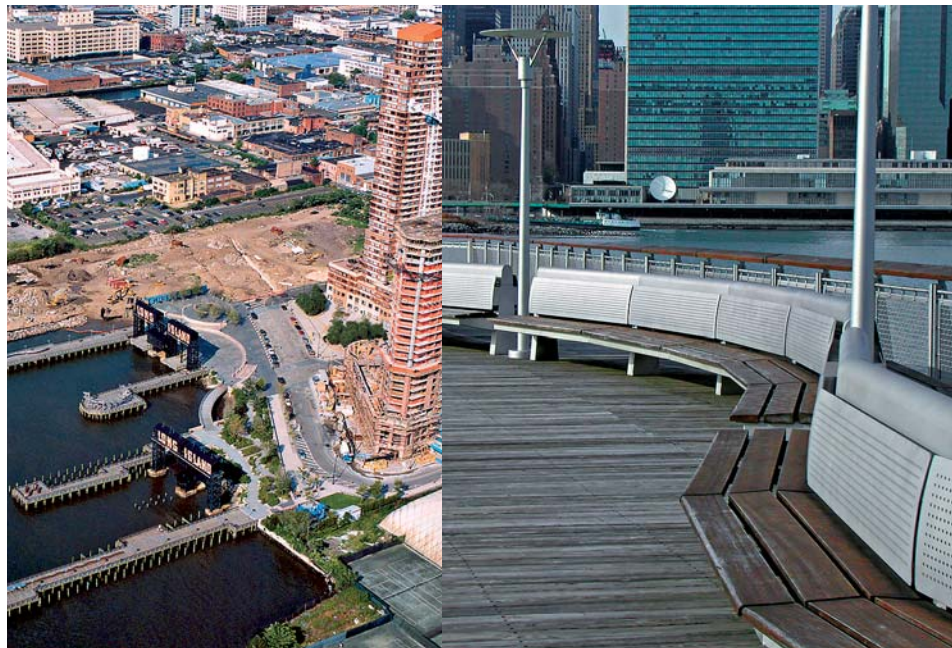
Type 316 stainless steel (UNS S31600, EN 1.4401, SUS 316) is generally the most cost-effective choice for low maintenance, boldly exposed, long-term applications near the coast. It contains 2% molybdenum, which helps to prevent corrosion caused by salt. For maximum corrosion resistance, a smooth, micro-crevice free surface finish is needed. In this case, the railings and seating are Type 316 stainless steel with a rougher glass bead blasted finish. Despite this finish, most of the Type 316 stainless steel has remained attractive and corrosion free. **(Figure B)**

Figures A and B The Gantry Plaza State Park piers jut into the East River and make extensive use of Type 316 stainless steel seating and railings. The United Nations building is visible across the river. (Figure A: Photo Courtesy of Abel Bainnson Butz, LLP)

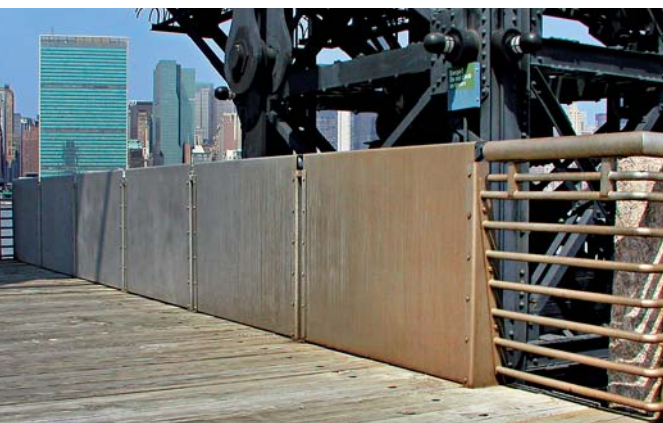
Figure C The Type 316 stainless steel has performed well on the piers. The exception is the splash zone, where there is discoloration caused by corrosion staining (right side of image).

Direct exposure to salt water spray or splashing is much more corrosive than typical coastal exposure. During high tide, brackish water hits the rocks and the old loading towers (gantries) concrete supports. Water splashes onto the stainless steel railings along the shore causing localized corrosion of the Type 316 stainless steel railings. **(Figure C)** Although it is unattractive, the corrosion rate is low and structural failure is not a concern. This staining is easily removed by cleaning.

After the Type 316 stainless steel corrosion problem was observed in the splash zone, a fifteen-month study was conducted using nine different stainless steel and finish combinations. All of the samples had rough finishes and were placed in the splash zone. Duplex 2205 stainless steel (UNS32205, EN 1.4462, SUS 329J3L) with a dull pickled finish provided the best performance. In localized splash zones, upgrading to a more corrosion resistant stainless steel can prevent staining. Higher strength duplex stainless steels can be used to reduce section sizes and material cost. A report on this corrosion study is available at <http://www.imoa.info>.

The splash zone had a score of 7. This indicates that Type 316 stainless steel would be expected to corrode and even duplex 2205 stainless steel would have some light corrosion staining over time. A smoother finish and/or annual cleaning would lower the score to 5 or 6 and there would be little or no corrosion of 2205 stainless steel. A smooth finish and regular manual cleaning would be necessary to keep Type 316 stainless steel attractive. Of the samples tested, 2205 duplex stainless steel had the best corrosion performance. Any stainless steel with similar or greater corrosion resistance and a smooth finish would also be expected to do well.
