Case Study 07 Barcelona Coastal Curtain Wall

Moderate Urban and Industrial Pollution
Moderate Coastal Salt Exposure

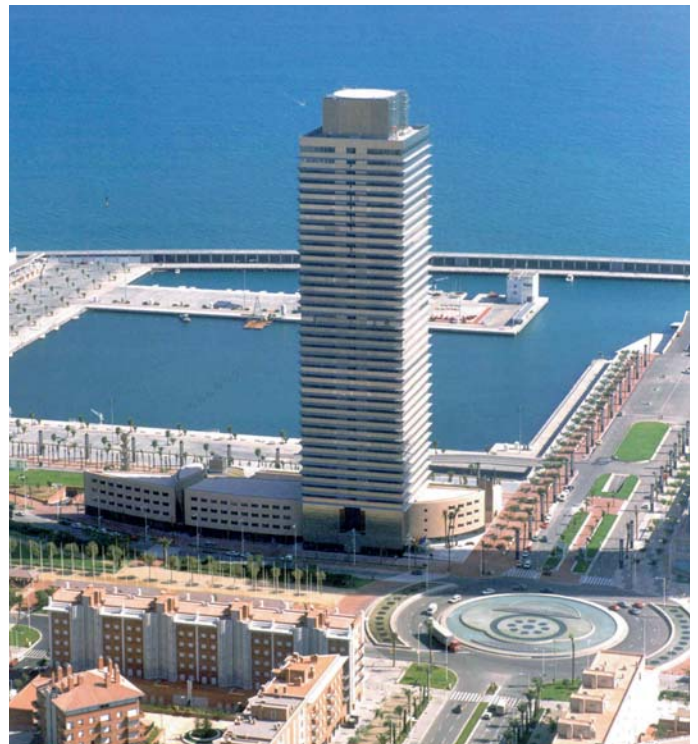
Figure A The Type 316 stainless steel clad Mapfre Office Tower is separated from the Mediterranean Sea by a park and marina. Despite the corrosive location, the appearance of the stainless steel is unchanged. (Photo Courtesy of ACERINOX)

The Mapfre Office Tower was completed in 1992 as part of Barcelona, Spain's Olympic village. **(Figure A)** The architect, Ortiz-León Arquitectos, is an environmentally conscious design firm and a member of the Spain Green Building Council. Íñigo Ortiz stated that the building was “designed to very high energy efficiency and environmental standards for its time. It would not be less than silver using the LEED (Leadership in Energy and Environmental Design) green building rating system.”

Barcelona is an important port city. Sea salt and high levels of air borne particulate from loading and unloading ships make the location corrosive. Occasional dust storms originating in the Saharan Desert add to the particulate levels. Locally produced Type 316 (UNS S31600, EN 1.4401, SUS 316) stainless steel and high-efficiency blue glass were used for the exterior.

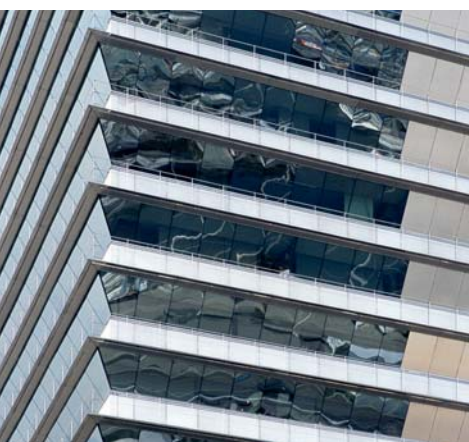
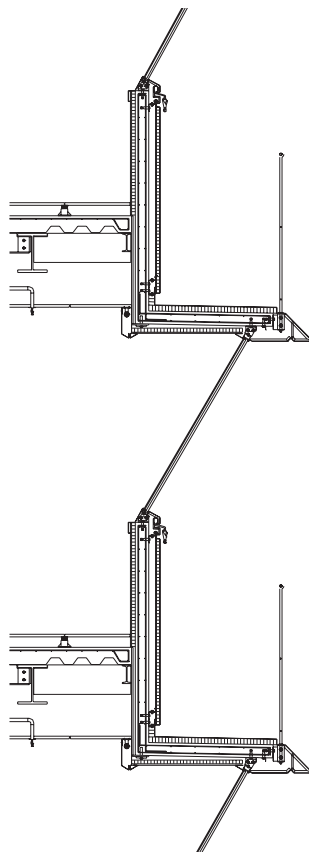
Figures B and C Thoughtful, environmentally conscious design using stainless steel improves energy efficiency, makes cleaning easy, and ensures an attractive appearance over time. (Design detail courtesy of Ortiz-León Arquitectos. Photo Courtesy of Martina Helzel)

Type 316 stainless steel contains 2% molybdenum, which helps to prevent damage from coastal salt and corrosive pollution. Exterior walkways provide easy access for window and wall panel cleaning at each floor, so that dirt and corrosive contaminants can be removed. **(Figures B and C)** Selection of Type 316 stainless steel and continued regular cleaning will keep the exterior wall panels attractive and corrosion-free over the building's life.

The inwardly sloping, glass windows are screened by the stainless steel panels. The design reduces energy consumption by keeping the building cooler. Most of the stainless steel is sheltered or horizontal which can increase dirt and corrosive deposit accumulation. Smooth matte and polished stainless steel finishes were selected to reduce surface deposit accumulation. The stainless steel panels also reflect natural light into the building.

Because stainless steel panels shield the windows to reduce energy consumption, most are either sheltered (+1) or horizontal (+1). Sheltered and horizontal locations are more corrosive, because they accumulate more surface deposits. The smooth surface finishes reduce dirt accumulation and provide better corrosion performance (-1). By selecting smooth finishes, the architect balanced the design score (-1 + 1 = 0).
