Case Study 07 Barcelona Coastal Curtain Wall

Moderate Urban and Industrial Pollution
Moderate Coastal Salt Exposure

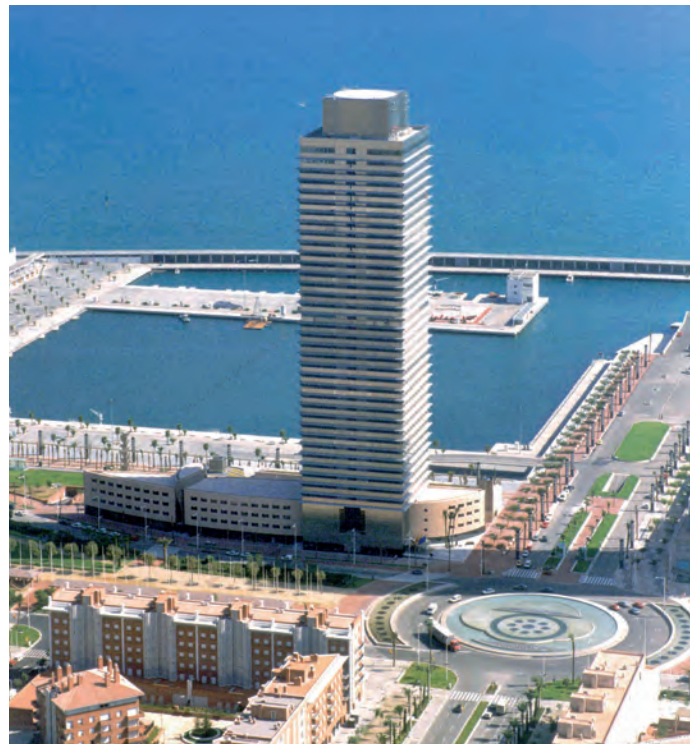
Figure A The Type 316 stainless steel clad Mapfre Office Tower is separated from the Mediterranean Sea by a park and marina. Despite the corrosive location, the appearance of the stainless steel is unchanged. (Photo Courtesy of ACERINOX)

The Mapfre Office Tower was completed in 1992 as part of Barcelona, Spain's Olympic village. **(Figure A)** The architect, Ortiz-León Arquitectos, is an environmentally conscious design firm and a member of the Spain Green Building Council. Íñigo Ortiz stated that the building was “designed to very high energy efficiency and environmental standards for its time. It would not be less than silver using the LEED (Leadership in Energy and Environmental Design) green building rating system.”

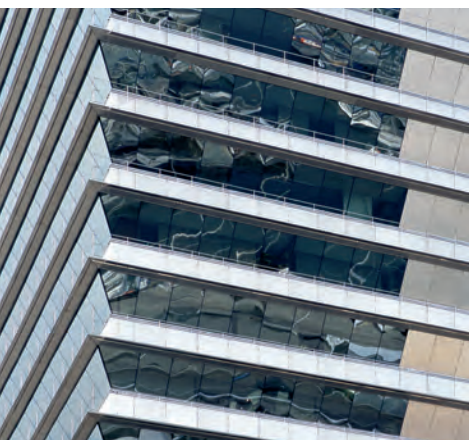
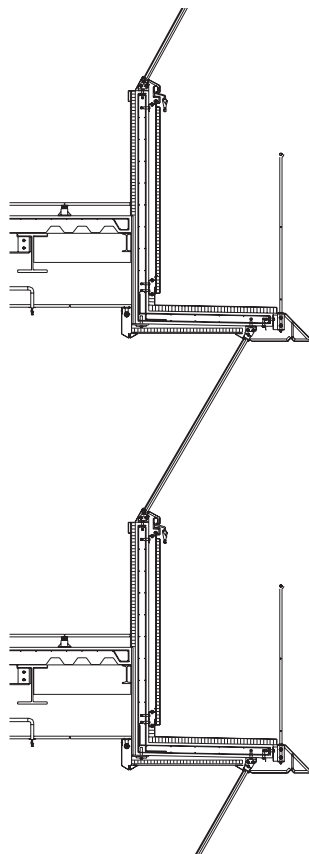
Figures B and C Thoughtful, environmentally conscious design using stainless steel improves energy efficiency, makes cleaning easy, and ensures an attractive appearance over time. (Design detail courtesy of Ortiz-León Arquitectos. Photo Courtesy of Martina Helzel)

Type 316 stainless steel contains 2% molybdenum, which helps to prevent damage from coastal salt and corrosive pollution. Exterior walkways provide easy access for window and wall panel cleaning at each floor, so that dirt and corrosive contaminants can be removed. **(Figures B and C)** Selection of Type 316 stainless steel and continued regular cleaning will keep the exterior wall panels attractive and corrosion-free over the building's life.

The inwardly sloping, glass windows are screened by the stainless steel panels. The design reduces energy consumption by keeping the building cooler. Most of the stainless steel is sheltered or horizontal which can increase dirt and corrosive deposit accumulation. Smooth matte and polished stainless steel finishes were selected to reduce surface deposit accumulation. The stainless steel panels also reflect natural light into the building.
