Bridge in Cala Galdana on Menorca

BRIDGE IN CALA GALDANA ON MENORCA

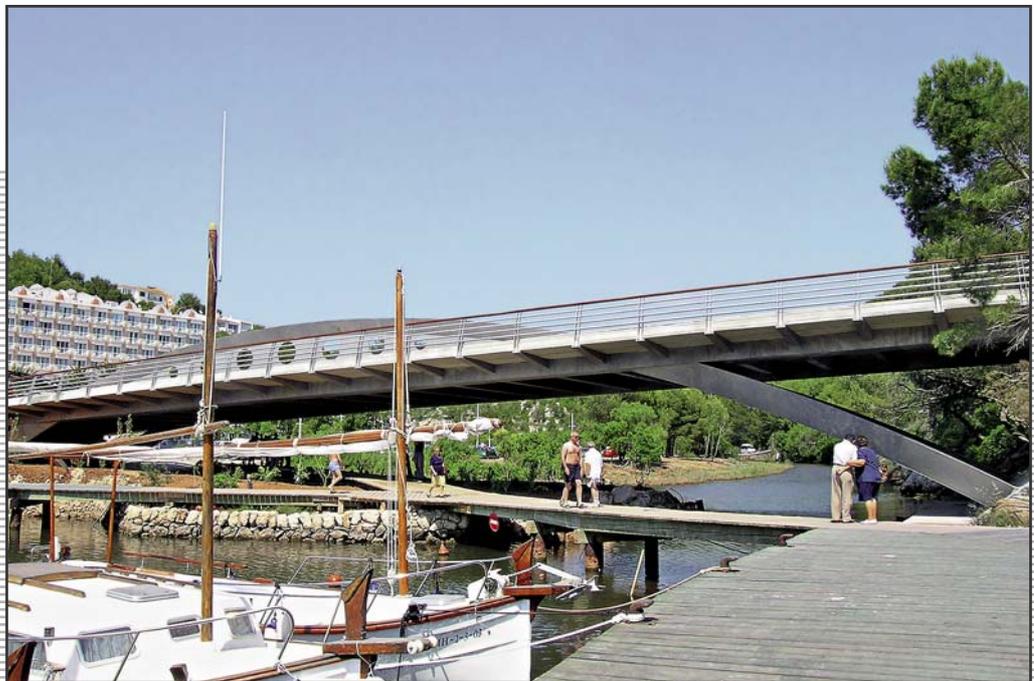
The inclined struts between the outer ends of the arches and the longitudinal beams take up the horizontal forces in the arches, thereby relieving pressure on the foundations.

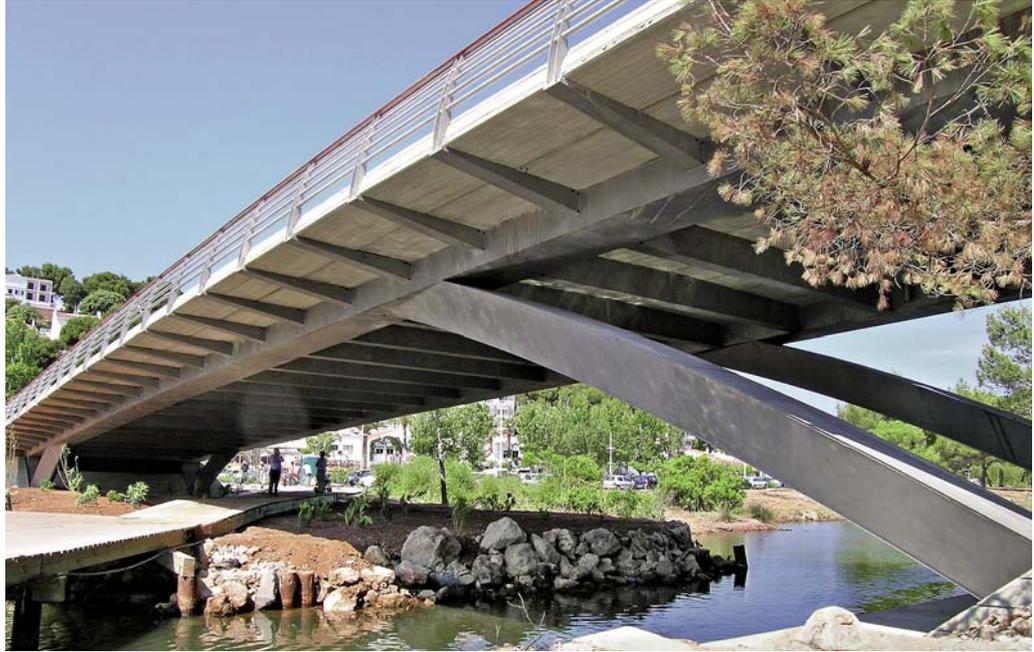
A pickling paste was applied to the stainless steel frame after welding, to remove discoloration and scale. The unified matt surface structure was achieved by subsequent beadblasting.
